| Erf number | Date built | Type of building |
| 737 | 1900s | Residential |
| 3 Krige Street Stellenbosch | | Dwelling |
| Erf No 737 | Contributing | IIIB |

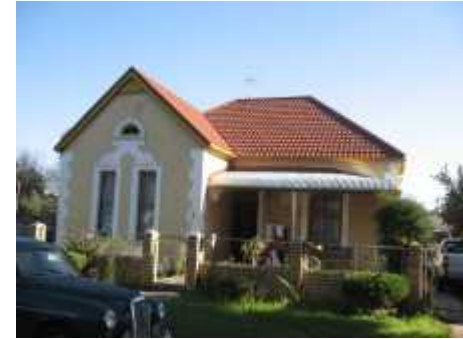
"Asymmetrical house with hipped corrugated iron roof. Projecting covered gable with semicircular vent and paired 1x1 sashes, with decorative plaster surrounds. Rusticated quoins. Hipped bullnose verandah on cast iron columns and brackets. 2x2 sashes; 4-panel door with fanlight. Facebrick garden wall"
