Assegaaibosch, Jonkershoek, Stellenbosch District

Assegaaibosch ridge

02.14/04

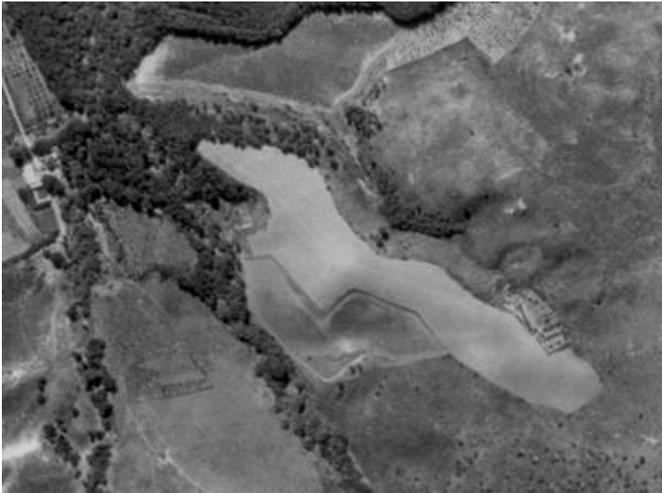
1938 aerial: the top and south west slope of Assegaaibosch ridge is cultivated. At the head of the seasonal stream (w) are trees in rows - a possible dwelling site.

In 1938 the top of the ridge was cultivated land. A clearing with trees in rows at the head of the seasonal stream west of the ridge may indicate a dwelling site, perhaps of farm workers.

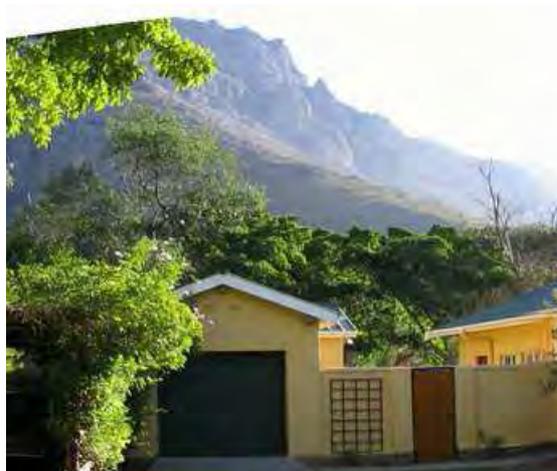
One of the three similar staff houses on Assegaaibosch Ridge.

Three undistinguished bungalows (beautifully sited for views) are sited along the crest of the ridge.

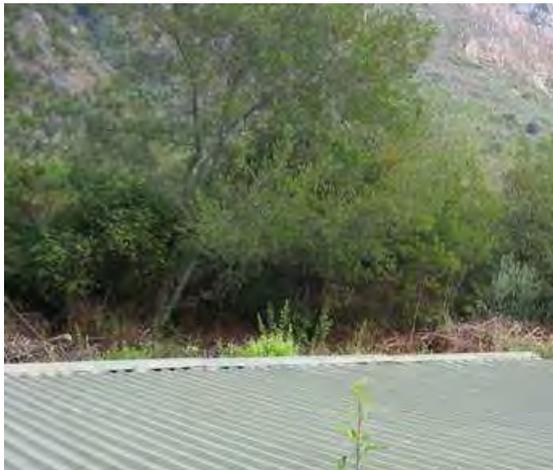
Covered reservoir, Assegaaibosch ridge

There are two circular concrete reservoirs on the ridge. The first is to the north of the road on the crest and is uncovered. The second is beyond the curve of the road as it begins to descend. It is covered with a metal roof and has associated plastic tanks, piping and pumps equipment.

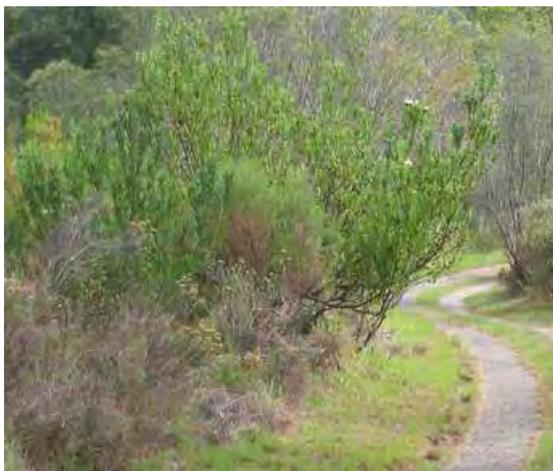
The ridge road on the west side.

A single-car wide road winds up the north face of the ridge above the river field (offering panoramic views over the valley) and across the top of the ridge. It provides access to the ridge houses (see Objects 02.14/04.02) and reservoirs (see Objects 02.14/04.03) before running down a shallow valley south of the ridge and crossing a concrete bridge over the Assegaaiboschkloof stream. Then it runs through the nature garden to rejoin the main Assegaaibosch access road.

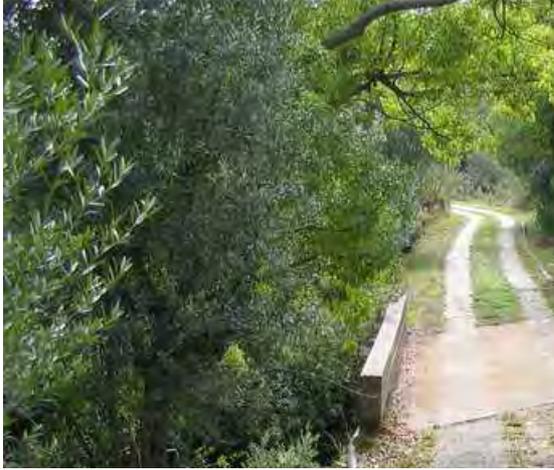
Assegaaibosch ridge road: the bridge over Assegaaiboschkloof stream.

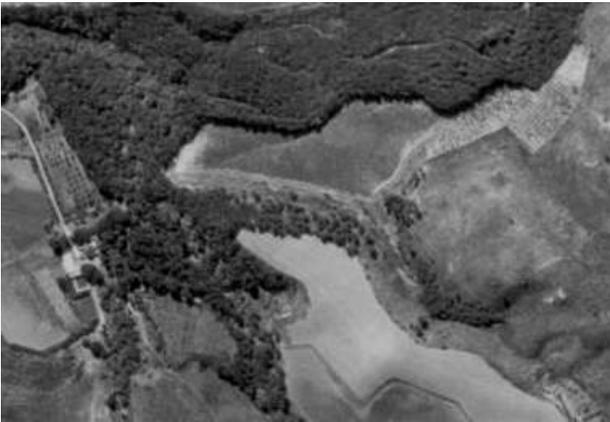
Area east of Assegaaibosch werf, 1938 aerial.
The river field appears to be grain (or could be vineyard) and there is an orchard in the east part.

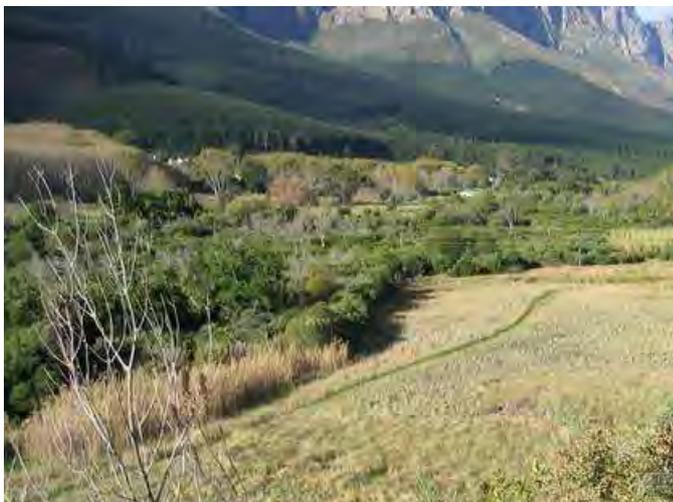
The river field, Assegaaibosch, is one of the few arable areas on the farm and was part of the earliest recorded grant

One of the series of level riverside fields backed by steep hills which is so characteristic of the Jonkershoek valley. It is bounded by the Eerste River in the north, the Assegaaibosch streams in the west, and backed in the south by the steep slopes of the Assegaaibosch ridge and the rounded hill east of it. It is presently vegetated with rough grasses, edged with a thick band of reeds along the Eerste River.

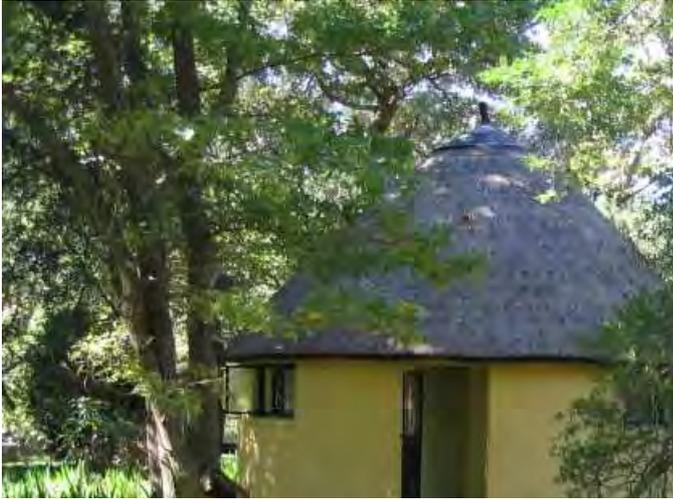
Ablution rondawel, picnic area, Assegaibosch

The picnic area is laid out in a well-wooded, flat area bounded on the north by the Eerste River, on the east and south by the Assegaibosch stream, and on the west by the access road from Jonkershoek. Trees include indigenous species and many oaks. Undergrowth is cleared, making a series of "dells", furnished in part with picnic tables. Near the access road and main entrance to the picnic area is a thatched rondawel containing ablution facilities.

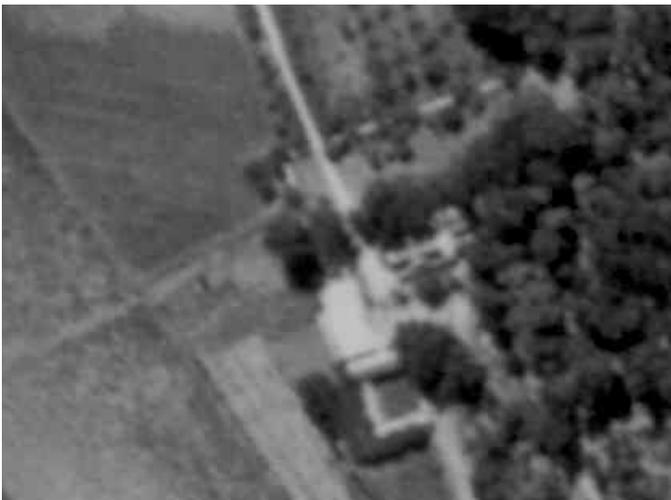
Assegaaibosch werf, 1938 aerial photo. H-shaped house just above centre, kraal and outbuilding (since demolished) behind it. Note the access road runs west of the house.

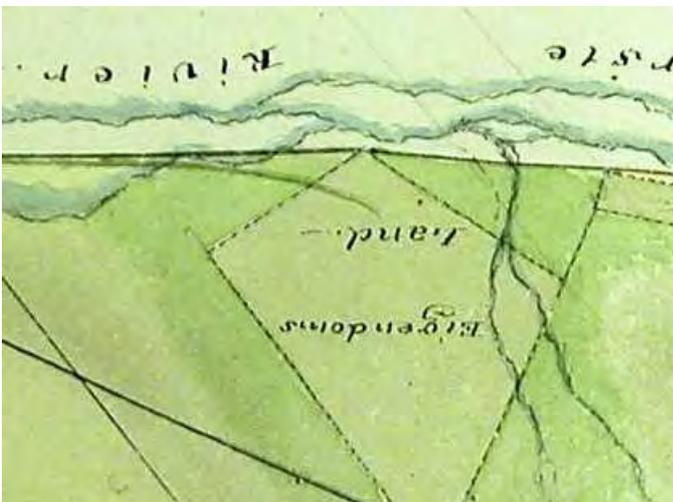
Assegaaibosch 1817 grant, detail. The werf is situated south of the end of the "wagen pad" seen entering the diamond shape of the earlier grant from the west.

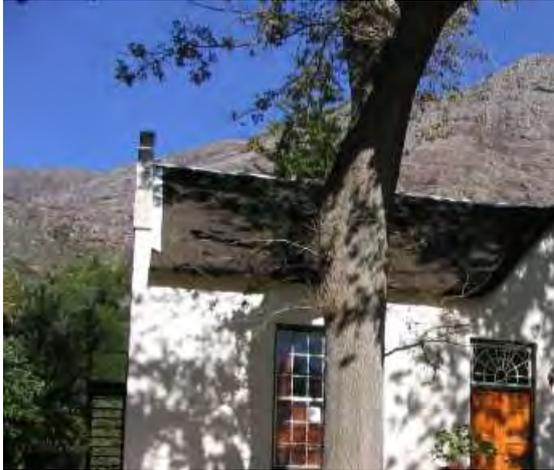
Assegaibosch house, front (north) façade

H-shaped thatched Cape gabled house, facing north, towards the river. The front has a dormer gable with casement window, while the rear and side gables are holbol with pointed tops decorated with a tassel. The front has three tall sash windows, with two panelled double doors with spoke fanlights flanking the central window. The rear has shuttered double and single casements and a stable door. A timber stair at the east leads to the loft. It has a tiled stoep on all sides, raised in the front, with slightly splayed steps, at ground level at the back.

fair

- * Care should be taken not to overdevelop further around the house.
- * Appropriate landscaping could mitigate existing negative impacts of nearby buildings, particularly in front of the house.
- * Further study of history of house. Check sales prices in 1792, cf 1806 to see if there was a substantial rise. Inspection of building fabric by an expert could reveal more information on dating and evolution, possibly from a T shape to the present H.

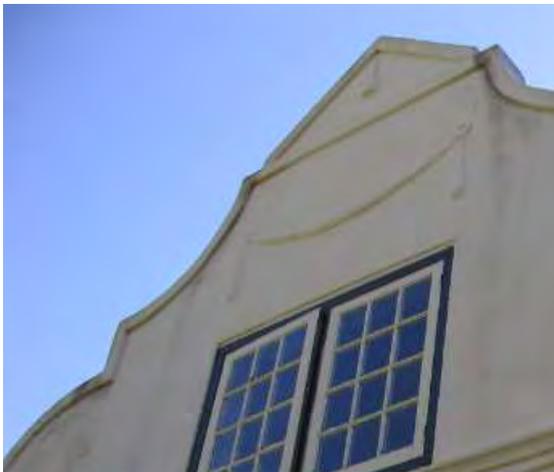
Assegaibosch house, rear gable

Fransen and Cook think Wouter Eduard Wium added the pointed back gable about 1825 (though de Bosdari dates it "soon after the year 1800") and the front windows and doors in the 1830s. (Fransen and Cook 1965:61, de Bosdari 1953:62). A similar neoclassical gable and double-front-door arrangement was introduced at Libertas Parva in Stellenbosch c1838.

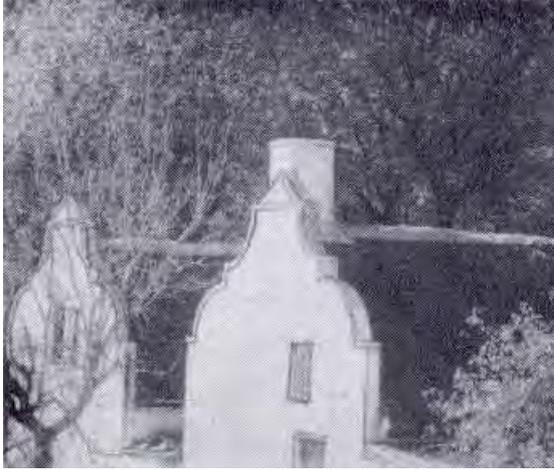
Assegaaibosch, side and rear , probably 1960s, prior to restoration. Poorly maintained, side court filled in, part-enclosed verandah at rear, various windows and doors.

When the Department of Nature Conservation bought the farm in 1960 the buildings were all neglected and in poor condition (see photo 4). It was arranged that Mrs AE van der Byl, then 97, retained usufruct of the house. It was subsequently restored by Cape Nature Conservation to its current appearance. See Fransen, 1967 and Hey 1995:129-131. Nearly all the woodwork had to be replaced. It was used as an educational and conference centre, and currently as visitor accommodation.
