Assegaaibosch, Jonkershoek, Stellenbosch District

Assegaaibosch werf

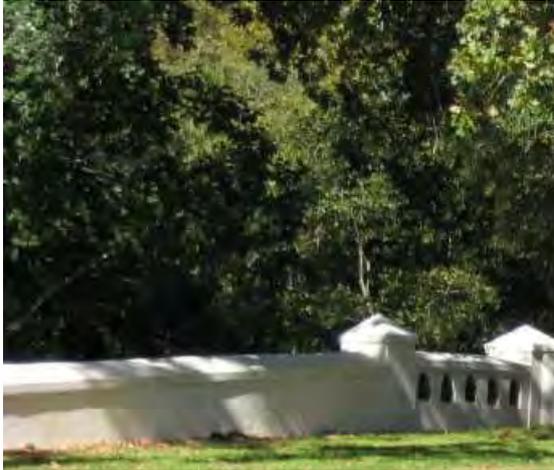
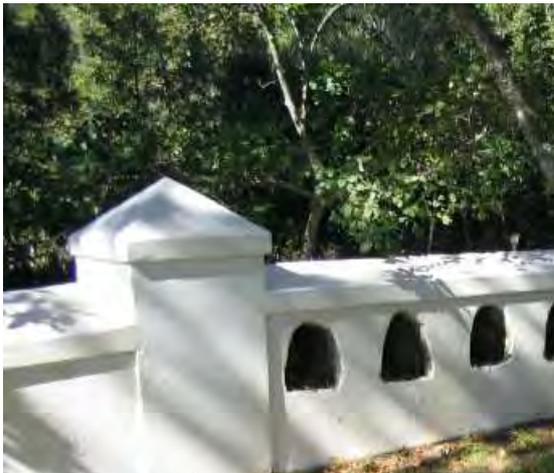
Fowl nesting places in the Assegaibosch werf wall

Between two pillars in the east wall just below the house is a row of 5 arched nesting boxes. It is unusual to have open nesting-places, particularly in such a remote and "wild" location; they are usually in an enclosed fowl-run in which poultry could be protected from predators.

The wall is a significant and typical element of Cape werfs. This one was largely rebuilt in the 1960s. The low, open nesting-places for hens are very unusual and impractical -- probably altered during restoration.

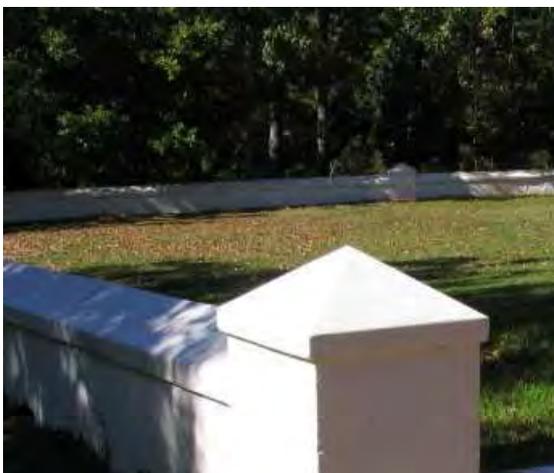
Assegaibosch werf wall: entry steps in front of house

A wide, low whitewashed wall with pointed capping and low, fat pillars encloses the house and "garden". Below the house is a gateway and cement steps with low, narrow (single brick wide) walls as edging.

The wall has been largely rebuilt and replastered and is very smooth, level and crisp, lacking the softness and patina appropriate in a rural setting.

good (over-restored)

The wall was largely rebuilt during the 1960s restoration.

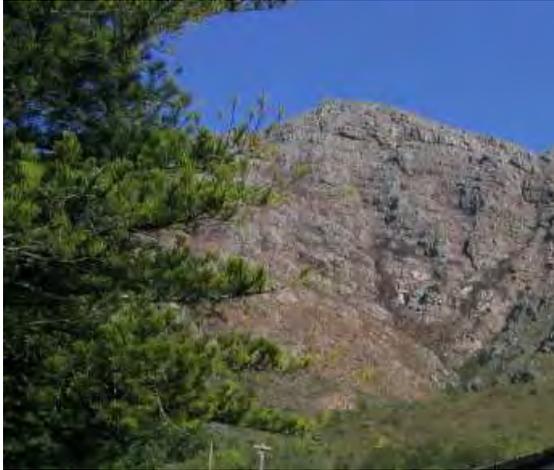
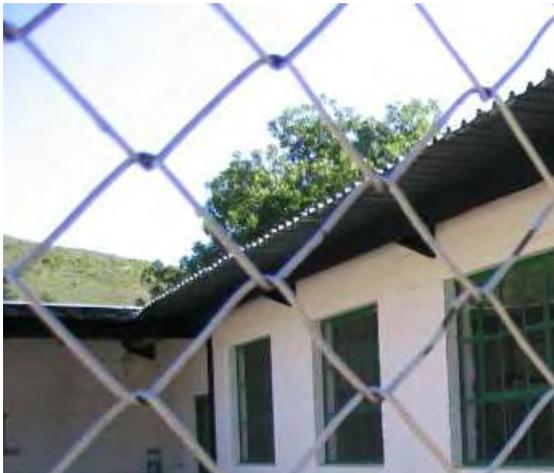
Assegaibosch kraal

Assegaibosch kraal, interior

Behind and west of the house is a large kraal (?), its base built of raw local stone and with a gate facing east. On top of the base wall a modern bagged brick shed has been built on the north side, and the walls raised on the other sides and roofed on the west and south to make open-sided sheds. The interior floor of the north half is level with, and slightly below the top of, the stone wall, while on the south side the cement floor rises with the ground, draining to a central channel.

The large square of this feature is clearly visible on the 1938 aerial photo, with a (probably pitched-roof) building on the north side and possibly with flat-roofed buildings on the west and south sides (see photo under werf Composite).

\* Further research required.

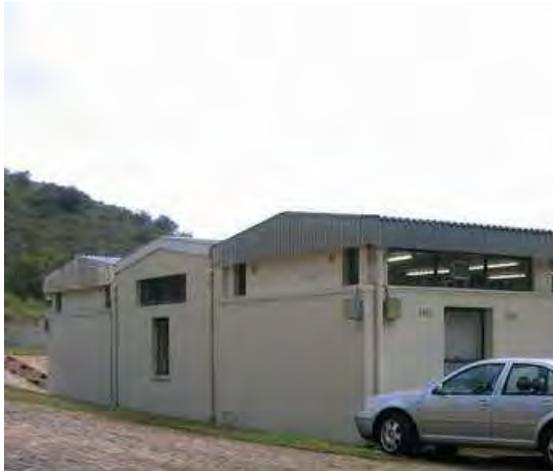
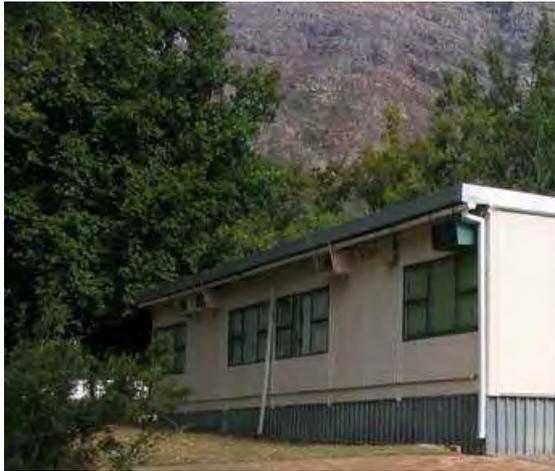
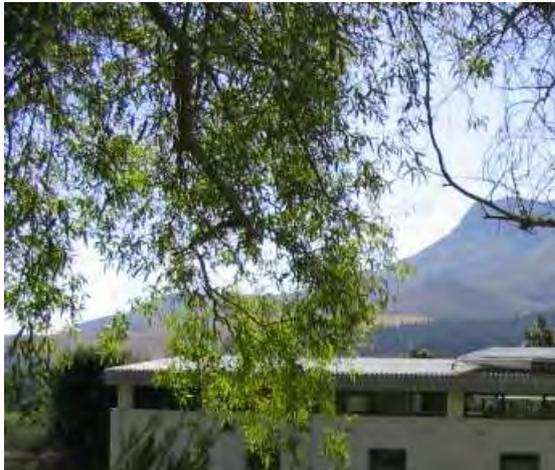
WCNC research offices below Assegaaibosch werf  
(No 1 on detail drawing of werf composite)

WCNC research offices just below Assegaaibosch house (No 2 on detail drawing of werf composite)

WCNC research offices west of house (No 3 on detail drawing of werf composite)

Around the historical Assegaaibosch werf are various buildings of Western Cape Nature Conservation. Three house offices and research facilities. Two are below the werf (photos 1 and 2) and one is west of the house (photo 3). No 2 is a prefabricated building. The other two are in a similar pragmatic contemporary style with white masonry walls, low-pitched metal sheet roofing with rolled edges, long, high windows below the eaves and other metal windows. Parking areas and paths around the buildings are in rough, unpatterned brick paving.

good

The prefab is of no interest. The office buildings are architecturally undistinguished but relatively "quiet", which reduces their intrusive impact. They are of some cultural and recent-historical interest because of their association with the transformation of the farm to a nature reserve, and the scientific research that has taken place in them. Further research into Cape Nature Conservation activities required for assessment of the role of these dams. Further research into Cape Nature Conservation activities required for assessment of the role of these dams. Further research into Cape Nature Conservation activities required.

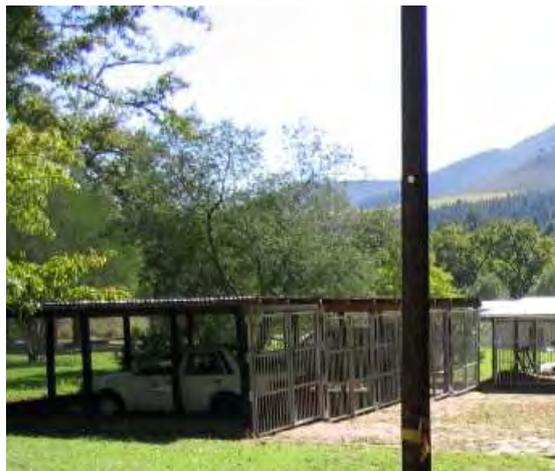
Carports below Assegaaibosch werf

L-shaped rows of carports; metal roofs on pole construction. Directly below and in front of the werf and house.

fair

Inappropriately positioned directly in front of the house, and intrusive in the werf environment.

This parking area should be moved away from the area directly in front of the werf, where it intrudes on the view from the house. The area should be appropriately landscaped.

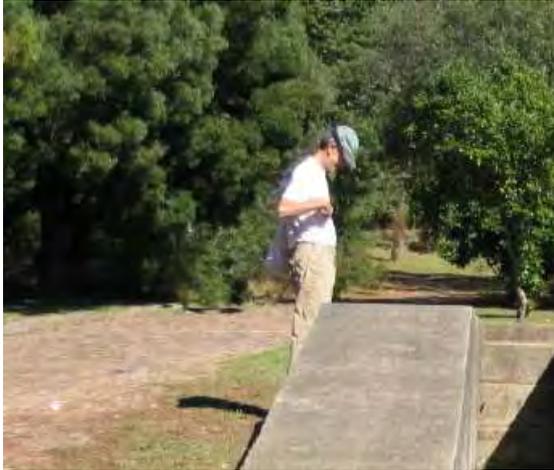
Workpit, Assegaaibosch werf

Just above the kraal, next to the road is a concrete workpit with ramps to drive up, and steps down into the pit at the upper end. Presumably for servicing nature conservation vehicles.

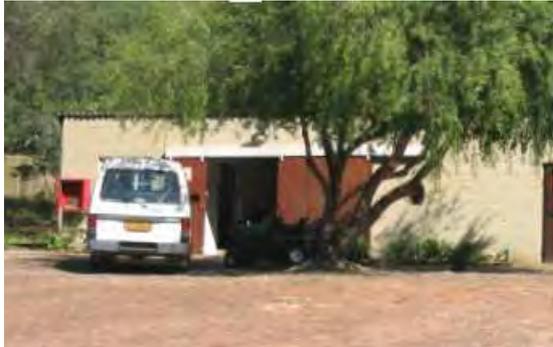
Workshop, Assegaaibosch werf

Monopitch workshop building with attached open-sided shed enclosed with metal mesh and gates. Large brick-paved yard in front, fenced from the road with split timber poles..

fair

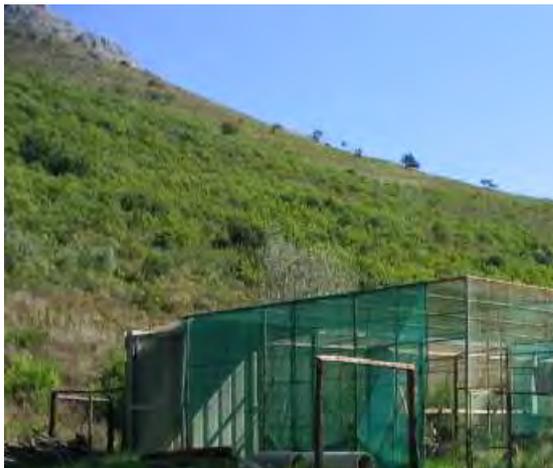
Raptor aviaries, Assegaaibosch werf

Sited on a raised, level bank adjacent to the workshop above the werf, only part of what was once a long row of cages remains (the foundations of the remainder are visible). The aviaries are of steel pole and mesh construction; those that survive are "furnished" with stone water features, hollow logs, etc.

Disused and mostly demolished; only a sample remains.

Conservation and interpretation as a demonstration of this particular activity in the history of CNC could be considered.

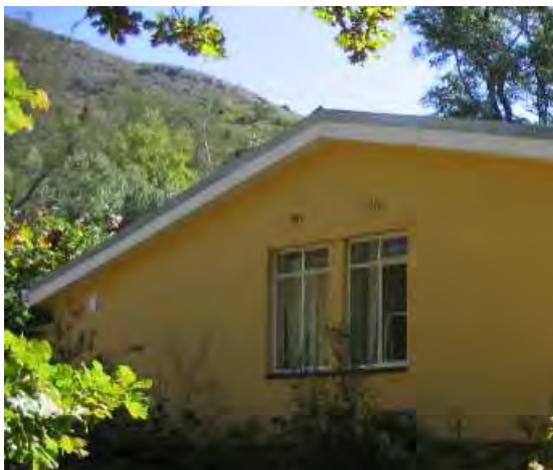
Staff house (south) above Assegaaibosch werf.

The access road continues past the workshops up the hill, parallel with the west stream, and ends at an undistinguished bungalow with steel windows.

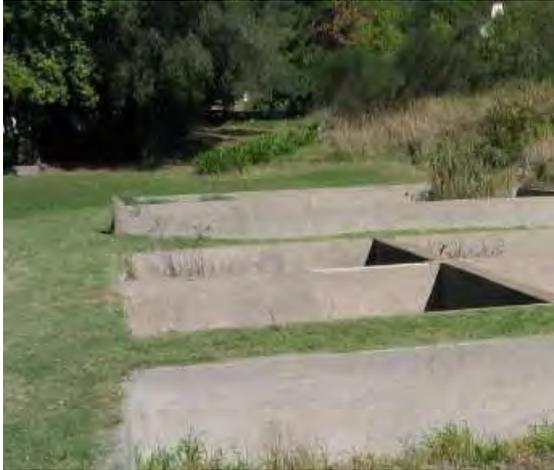
Concrete tanks, west of WCNC's main research offices.

In the garden behind WCNC's main research offices is a row of concrete tanks, set into a bank., Built for rearing water fowl, they are currently disused. Beyond them, to the west of the werf, at the edge of the valley, are two dams, currently fairly overgrown.

Disused.

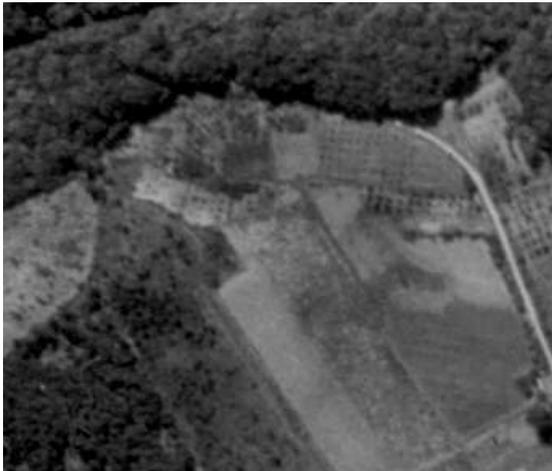
1938 aerial showing road entering werf west of the house. The present road runs along the east edge of the field.

The 1902 (Brink) map shows the main access road for the valley as a whole running along the south bank of the Eerste River, not the north as it does now. It entered Assegaaibosch and shortly thereafter crossed the river to the farms on the north bank. Although not shown, the road to Assegaaibosch continued on the south bank. This road is visible on the 1938 aerial, curving upwards parallel to and west of the axis of the house.

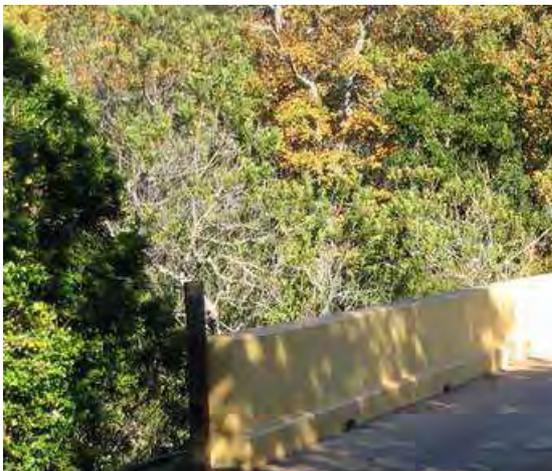
Bridge to Assegaaibosch from Jonkershoek

After the acquisition of the property by Nature Conservation in 1960, Hey (1995:129) writes that the "first step was to provide access from the hatchery. . . the Provincial Roads Department . . . Estimate of the cost was far beyond our means. We therefore decided to build the bridge departmentally, based on a simplified design . . . We were fortunate in finding a suitable site, where both the banks were higher than flood level and holes could be excavated to below the river bed, to cast solid foundations for the pillars. Using cut-off pine timber from the local saw-mill for shuttering, a strong reinforced deck with raised sides for added strength, was cast to connect the pillars. Despite all the dire predictions, the bridge has survived many floods and is still in use today, thanks to the good work and ingenuity of our foreman carpenter Mr James Adendorff and the works team."

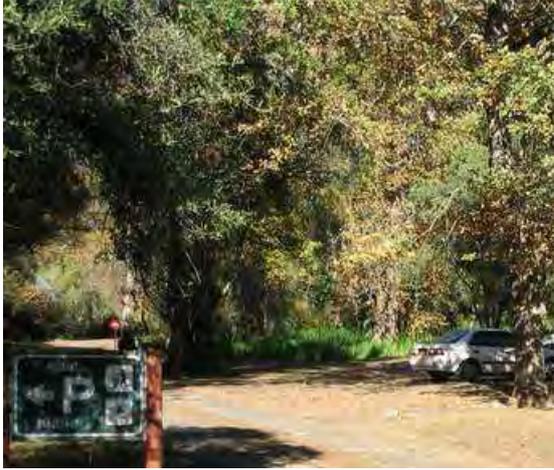
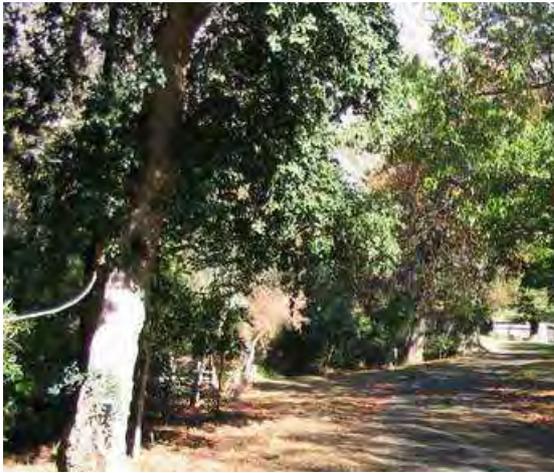
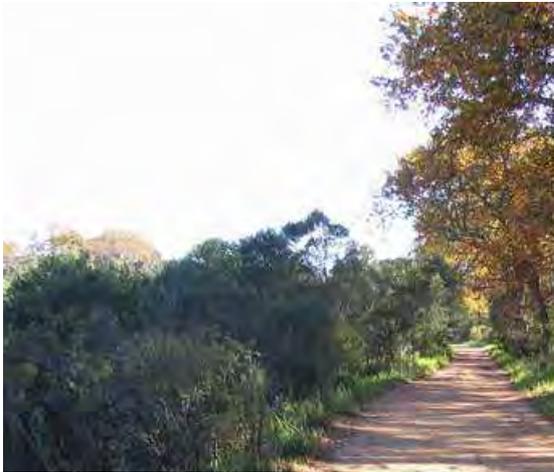
Assegaibosch, road and parking for WCNC offices

Assegaibosch, road toward the werf wall

The old road south of the river, typical riverine forest and oaks on the right.

The old road to Assegaibosch still runs from the west boundary along the south bank of the Eerste River. The main access road to the werf is now from Jonkershoek. It crosses the Eerste River over a concrete bridge and runs east of the werf, near the banks of the stream. It is paved in parts with rough brick, as are various parking areas associated with the offices.

The access road was moved to the east, probably at the same time. A line of trees on the werf still shows the alignment of the old road.

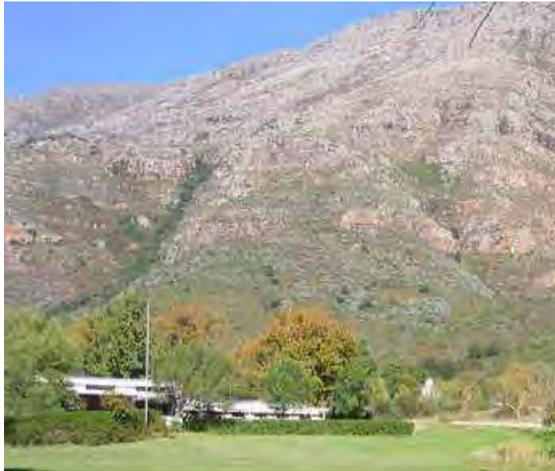
Assegaaibosch werf north meadow

Below the werf and above the old road is a meadow with clumps of trees, sloping up to the buildings and the dams to their west.

The open meadow provides a suitable "forecourt" for views up towards the werf and of the kloofs beyond; it is part of the werf landscape.
