# Heritage Survey: Stellenbosch Rural Areas

by Penny Pistorius and Stewart Harris - June 2004

02.27

Lingen, Jonkershoek, Stellenbosch District

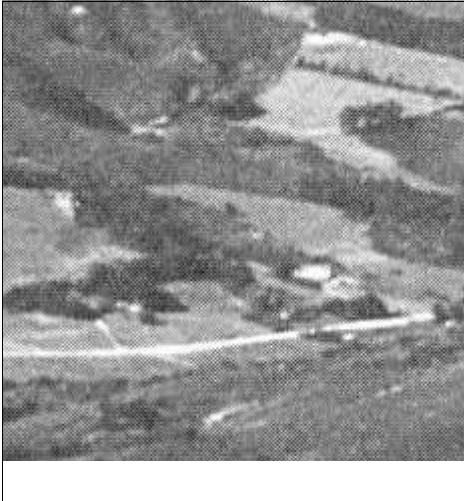
1950 photograph. The property is the clearing, centre, with trees behind and above; the white blob must be the new house. Studio Lockley.

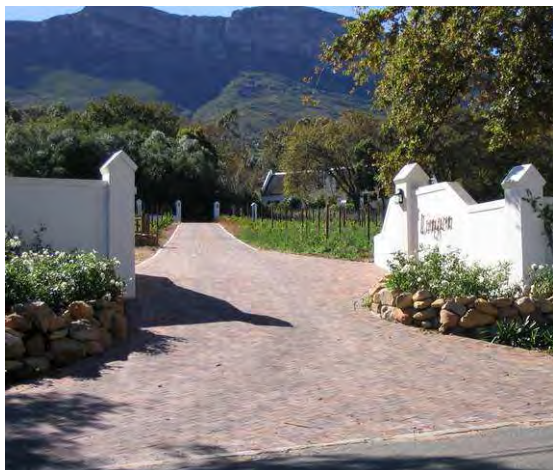
Lingen entrance

The boundary has a post-and-rail fence at the top of the bank along the Jonkershoek road. The entrance off the road is through a (contemporary) gateway with plastered pillars and wall, in a landscaped rockery. Through the gateway and up the brick-paved road, the house can be glimpsed beyond vineyards, in a well-treed garden behind a fence with white pillars.

Contemporary structure

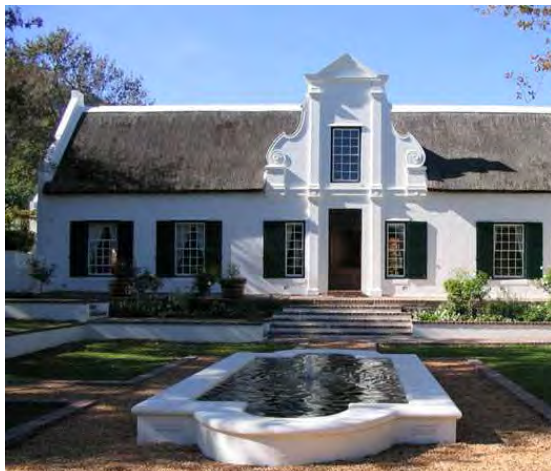
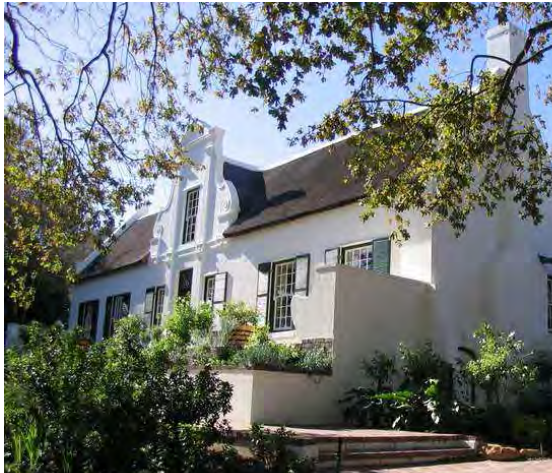
Lingen house, front (west)

A large mid-20th C Cape Dutch Revival thatched, gabled house set at an angle on the slope in a fine garden.

Good

Cape Dutch Revival

Built in the late 1940s (owner, pers. comm.)

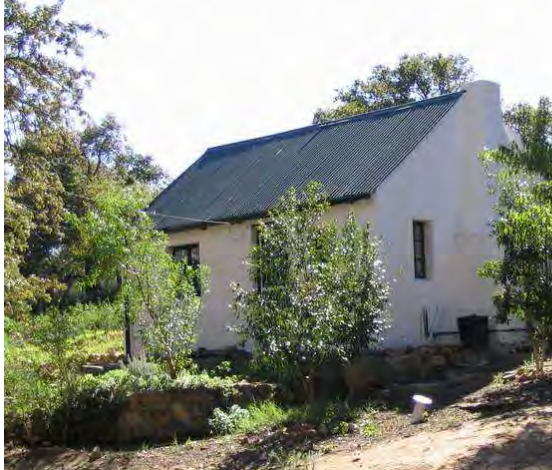
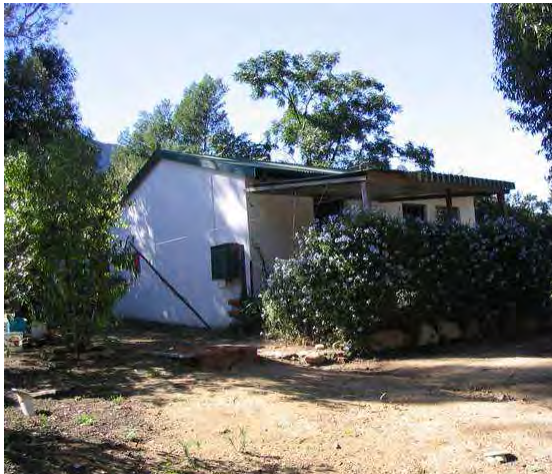
Worker's house, Lingen

On the top of the bank, to the west of the entrance near the Jonkershoek road are two workers' cottages of a similar type to those on adjacent Bergsig (02.26): they have corrugated iron roofs with a steeper pitch in front than behind, projecting hearth and chimneys, steel windows and stable doors. Neatly kept, they have low walls of heaped stones demarcating gardens and pathways.

Good

vernacular

Further research necessary.

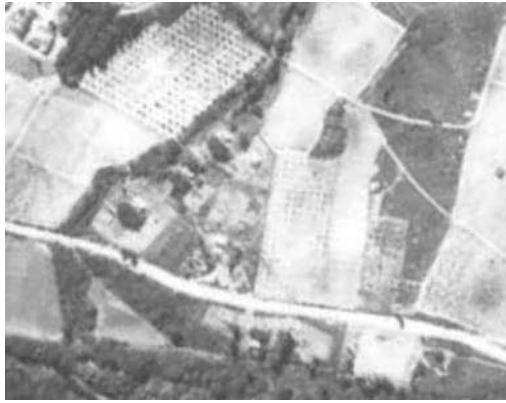
1938 aerial photo

The cottages are not clearly visible on the 1938 aerial photo, but may have already been present.
