Heritage Survey: Stellenbosch Rural Areas

by Penny Pistorius and Stewart Harris - June 2004

Jonkershoek

Waterfalls, Jonkershoek, Stellenbosch District

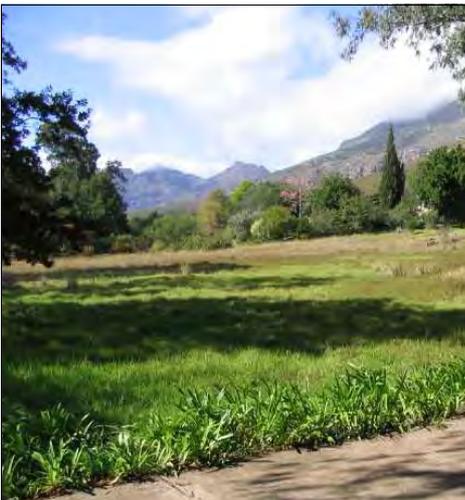
Waterfalls watermeadow from the driveway, looking towards Pontrieux; the stones at right are along the water channel above the field.

Smallholding on the lower slopes of Stellenboschberg, bounded in the north by the south bank road and on the north, east and south sides by parts of Pontrieux (Property 02.12), and on the west by Waterhof (Property 02.10) . The lower part is a rough field (part of the watermeadows), with a band of old gums along the western edge (Photo 2).

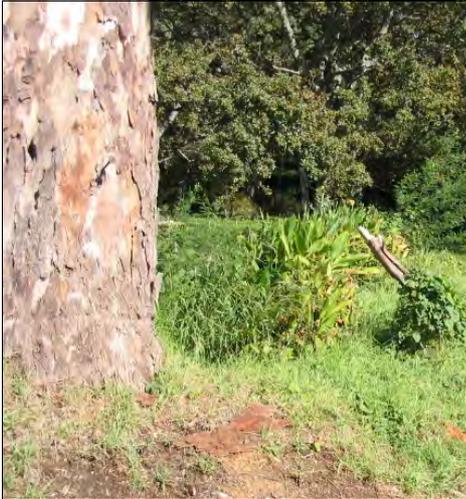
Waterfalls. The bottom water channel (line of canna lilies, centre) from south bank road; gatehouse cottage in background.

A water channel from the Pontrieux watermeadow passes under the road in a culvert and crosses the north west corner of the field (Photo 3). It passes behind a vernacular-style (post-1938) house in the north west corner of the property (Photo 4) and continues into Waterhof. Another water channel, partly stone-edged, enters from Pontrieux higher up the slope and runs along the top edge of the field.

South bank water furrow and old road across the property are older than 60 years (S.34) and archaeological (S. 36). The route of the water furrow is historical and it should not be modified. See Catalogue nos 02.00/02 and /03.

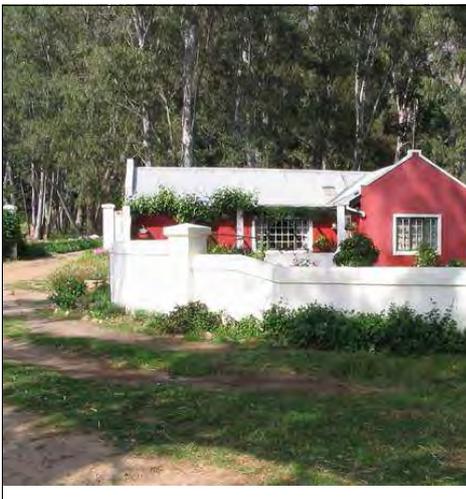
Waterfalls: gatehouse cottage from south bank road

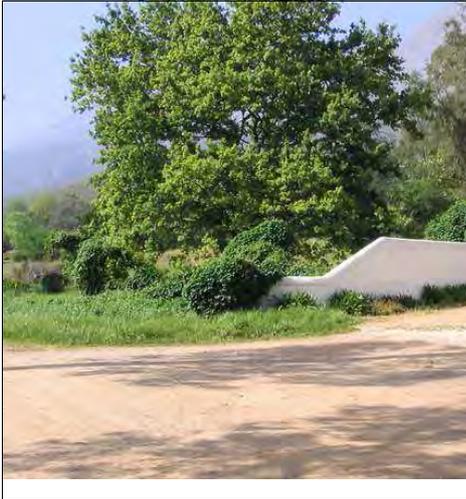
Waterfalls gateway

A road east of the house enters a modern gateway (Photo 5) and winds up the hillside through copses of trees and shrubbery to a cluster of houses higher up the slope (see Composite). A stream enters at the top of the property (from Pontrieux) and is captured in tanks above the houses. The land above the houses is not farmed.

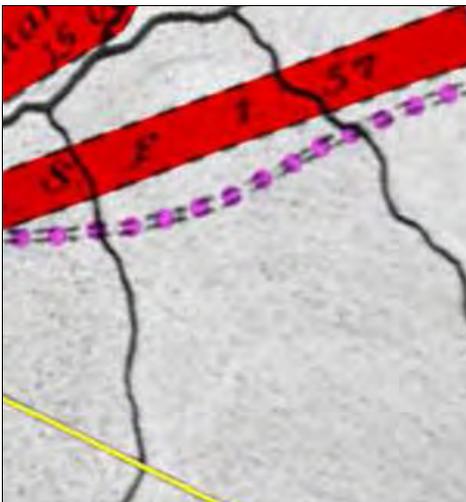
CAM2-409

1902 map: Red blocks 17th century grants, yellow lines early 19th c, pink dots roads. Grey/black rivers.

This property was till the recent past the core of a property that included Pontrieux (see 02.12) and its name Waterfalls probably applied to the whole property. It lies on land granted in 1817 but the convenient flat land at the north probably came into use soon after 1692 when the free black Jan of Ceylon was granted property along the south bank of the Eerste Rivier (photo 6). For a fuller history of the entire original farm see Old Nectar Historical Property.

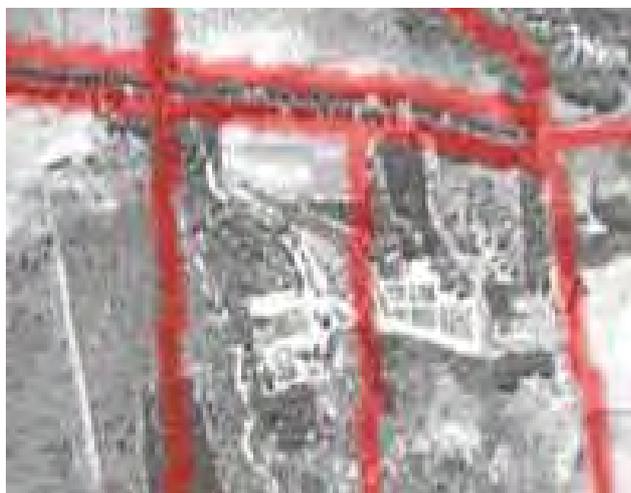
1938 aerial photo, approximate current cadastrals added. Note the close relationship between the homestead and the terraces east of it, now on Pontrieux.

The homestead (terraces, main house and an outbuilding below and east of it) and the winding road that leads to it were in place by 1938. The main house may be early 20th century or late Victorian (like the terraced orchards now in the land of Pontrieux) and at least the lower parts of the dry-stone retaining wall are probably of this time as well.

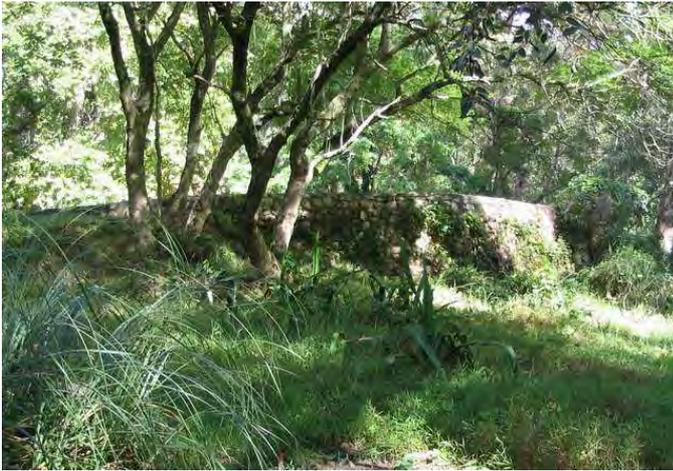
Stone wall retaining the terrace in front of Waterfalls house, from the driveway below.

The main building cluster is roughly at the centre of the property, on the slope. Below the main building cluster is a high dry-stone retaining wall to a terrace (Photo 03), and the main house (Object 01) is sited on a higher terrace. There are several other guest accommodation units at the side of and behind the house (Photo 4), one of which may incorporate an older outbuilding (Object 02). On the property to the east (Pointreux 02.12) are terraced orchards, once part of this cluster.

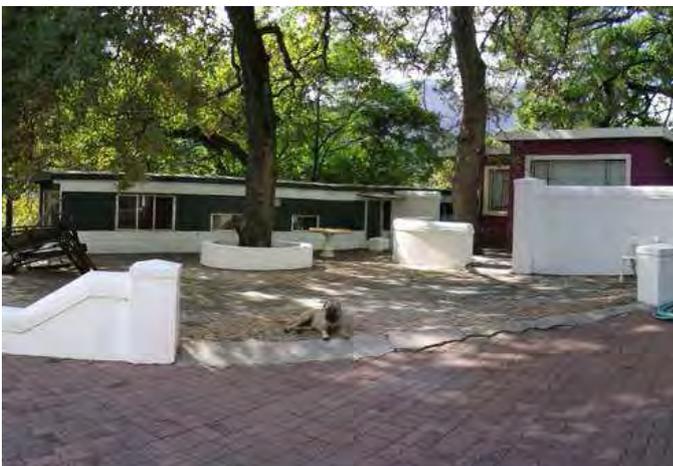
Guest units east of the house.

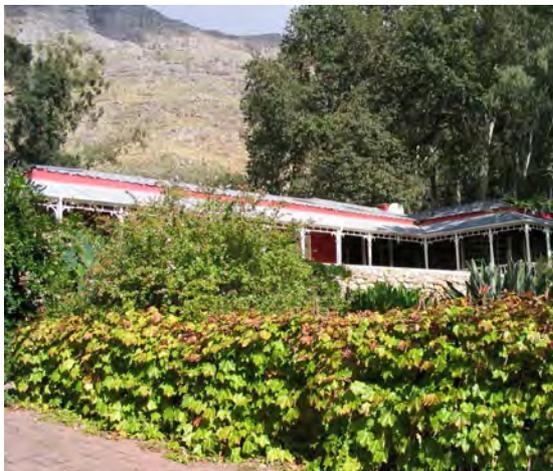
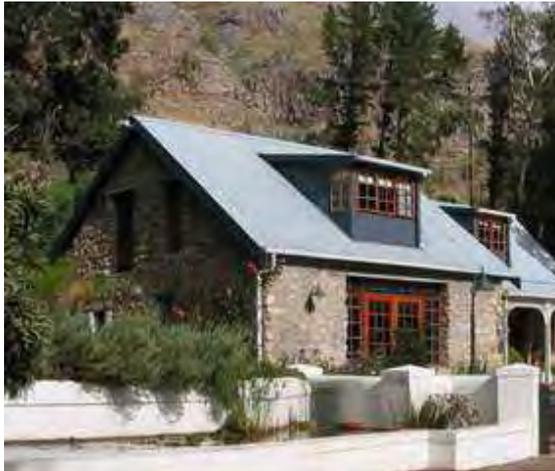
Waterfalls main house from below.

Waterfalls main house from the east, with stone guest cottage left.

The main house is on a level platform with stone retaining walls below. It is T shaped, with the long wing (possibly an extension) along the contour and the shorter bar towards the west. It has low-pitched hipped asbestos cement roofs and corrugated iron wrap-around verandahs with timber columns and simple fretwork. Apparently considerably altered, it probably incorporates older fabric.

Good

Further research necessary.

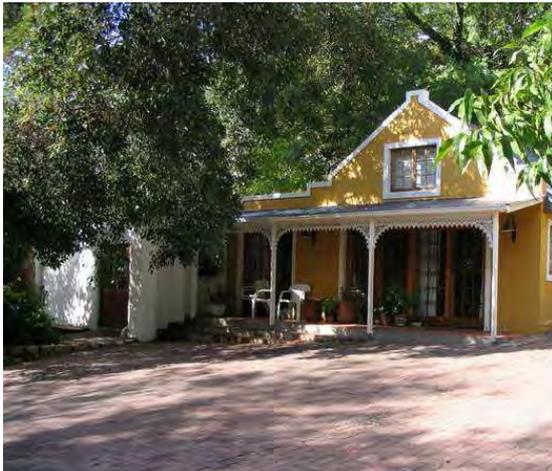
Yellow house, Waterfalls.

Below and to the east of the main house is a cottage which appears to be contemporary but probably incorporates a pre-1938 outbuilding.

Good

Further research necessary.
