# Heritage Survey: Stellenbosch Rural Areas

by Penny Pistorius and Stewart Harris - June 2004

02.12

Pontrieux, Jonkershoek, Stellenbosch District

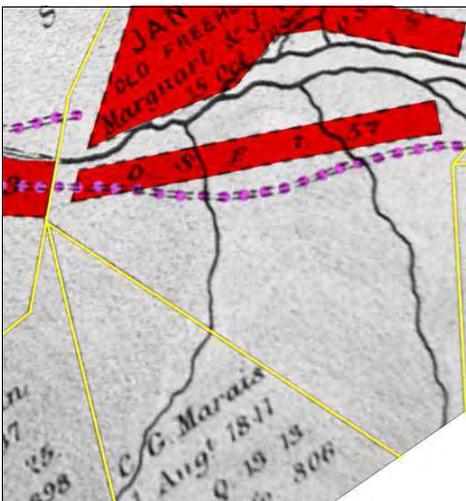
1902 map: Red blocks 17th century grants, yellow lines early 19th c, pink dots roads. Black rivers.

In 1938 the various portions of farm 350 were one property. The original buildings seem to be on adjacent property Waterfalls 350/2, with terraced orchards to the east on what is now portion 3. See Composite 2. The old south bank road to Jonkershoek and Assegaibosch had a different alignment from the present road: its route is shown on the 1902 map. See Composite 1.

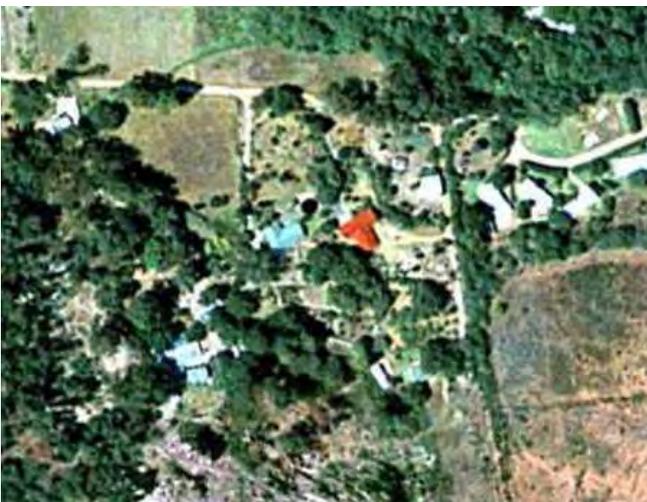
Pontrieux werf, 2000 colour aerial. Two modern houses have green and red roofs; behind them are the orchard terraces, above them guesthouse cottage is at a slant with worker's house east of it.

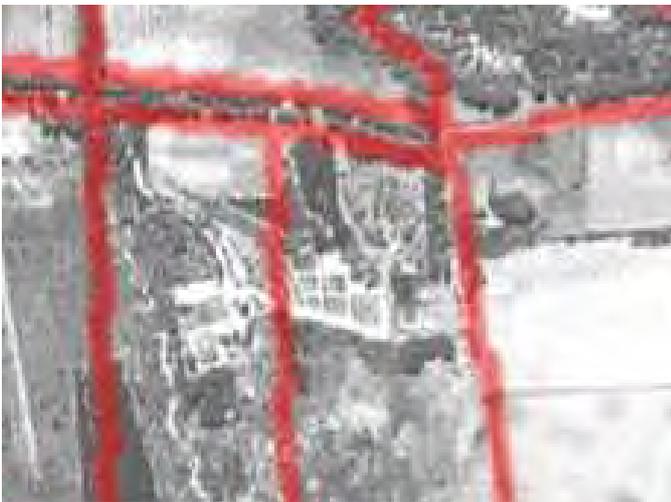
Pontrieux werf, 1938 aerial photo

See Property. In 1938 (see photo 2) farm 350 included the adjacent property Waterfalls, where the house was located, and this portion was part of an extensive farmstead associated with the house. When the property was subsequently subdivided into four portions (date not known), the one with the house on was alienated and is now separately owned. Except for the terraces (Object 01) it is difficult to make out any structures on the 1938 aerial photo. Mr Booie, who has worked on the farm since the 1980s, told us that his house (photo 5) was built on the foundations of an older dwelling and that the guest cottage (Object 02) was the only other old building.

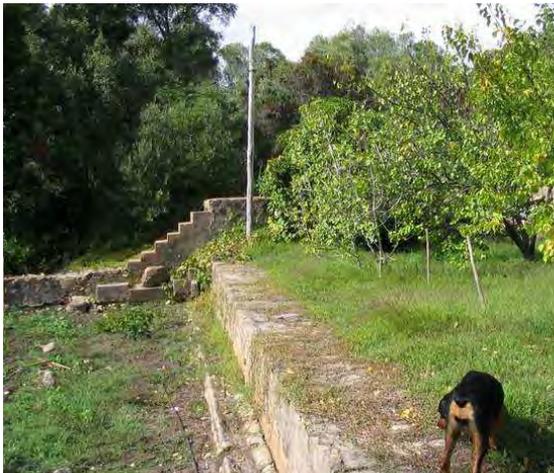
Retaining walls and stepped cross-walls dividing orchards

The slope behind the modern houses is terraced, with 1m wide random stone retaining walls along and across the contour, dividing the land into roughly rectangular, level fields which step up to a particularly high and substantial wall which curves along the contour in the south. The tops of the walls are plastered and form paths, with steps up and down to other walls and the fields where required. The upper terraces are orchards in which several old fruit trees may survive from earlier owners, while that nearest the west house is a kitchen garden. Along the western edge of the terraces is a plastered water furrow which runs from a furrow above the top wall down to the house and thence across to Waterfalls. We did not find sluices and side channels which would have enabled the orchards to be irrigated; they may have been destroyed, or be buried.

fair, some crumbling

Should be preserved. Further research necessary.

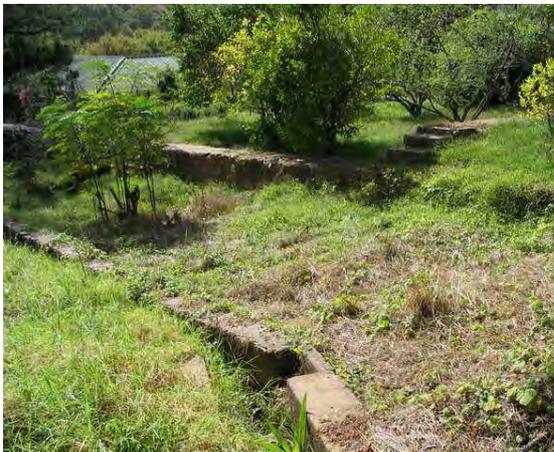
Water channel along western edge of terraces

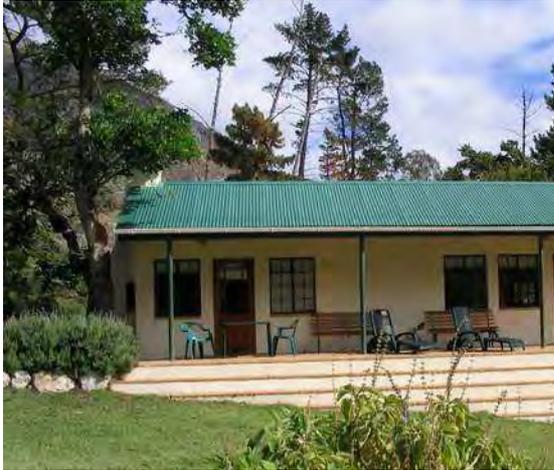
Pontrieux guest cottage

Simple cottage with iron double-pitched roof and verandah facing east, with steps edging the platform on which it sits. On the west side it has a timber deck overlooking the stream along the boundary. It accommodates two guest units with timber casement windows.

Good

A photograph in the cottage shows that prior to its conversion it was workers' accommodation of five rooms, each with an external door and double casement window. It was altered to two guest units after the 1980s, apparently re-using the windows.

Further research necessary.

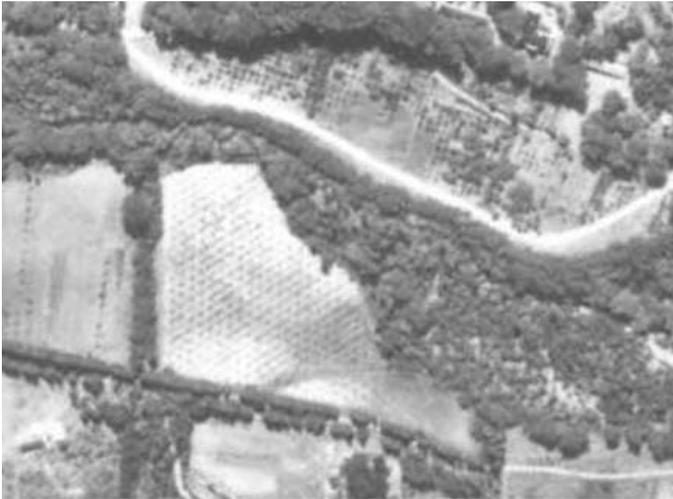
Pontrieux watermeadow, 1938 aerial photo. Note the diagonal texture (vineyards?) and the curved irrigation channel.

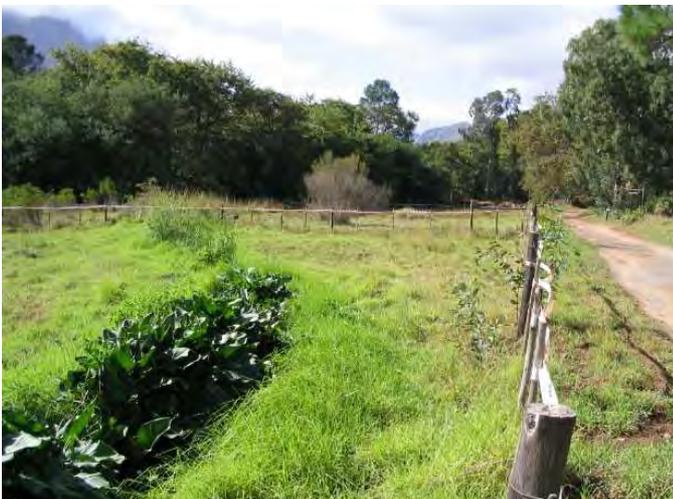
The irrigation furrow. The south bank road previously ran along the right side of the furrow and into what is now the Swiss Club.

A typical Jonkershoek watermeadow: flat, fertile and well-watered. It is currently rough pasture, divided by fences into camps. The northern Eerste River edge has a fringe of riverine forest, including introduced trees such as oaks, gums, and poplars. An irrigation furrow from the stream (possibly man-made) along the east boundary crosses it and passes under the south bank road, continuing through the above-road properties to the west.

See Property. The old road to Jonkershoek farm and Assegaibosch crossed this water meadow (see 1902 map and 02.00/02), probably along the line of the irrigation furrow, which was certainly in place by 1938 (see also 02.00/03).

South bank water furrow and old road across the property are older than 60 years (S.34) and archaeological (S.36). The route of the water furrow is historical and it should not be modified. See Catalogue nos 02.00/02 and /03.
