Heritage Survey: Stellenbosch Rural Areas

by Penny Pistorius and Stewart Harris - June 2004

02.10

Waterhof, Jonkershoek, Stellenbosch District

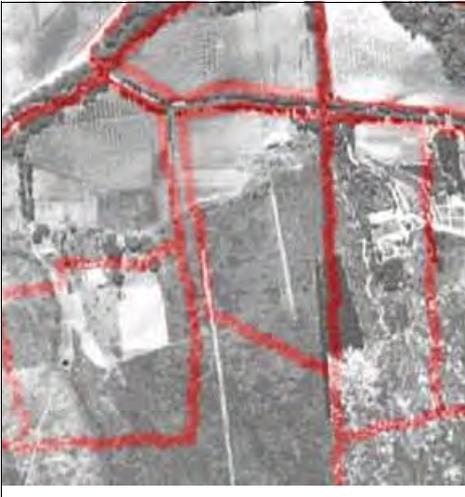
1938 aerial photo with added current cadastrals. The long white lines are scratches on the photo.

Main features such as the field with rough mountain slopes above, the water furrow and the dwellings of this portion were substantially in place in 1938, when the property was apparently still part of Glen Connor.

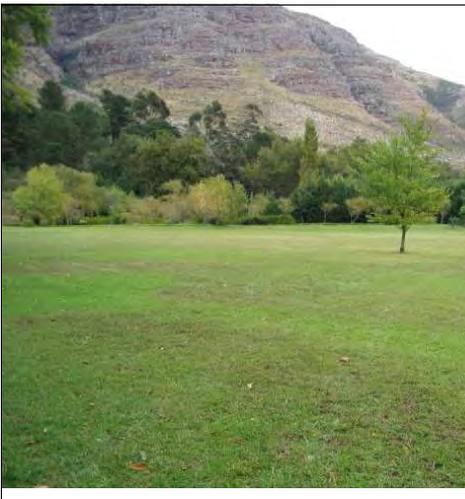
Waterhof water meadow

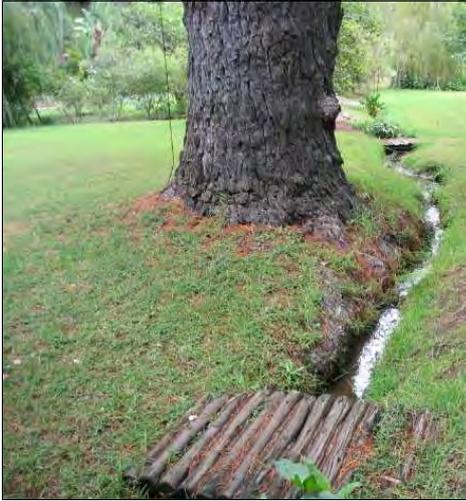
Photo Title
Waterhof: water furrow behind house

The old road cut diagonally across the site, along the south edge of the watermeadow; its route close to the south bank water furrow that enters from Waterfalls and runs behind the house cluster (Photo 4) to a dam at the west end. (See Catalogue nos 02.00/02 and /03.) There are also other drainage systems -- on the east boundary capturing the Waterfalls tributary and along a road on the west side that leads to Waaiwinde (Property 02.07) above.

South bank water furrows and any remnants of the old south bank road across the property are older than 60 years (S.34) and archaeological (S. 36). See Catalogue nos 02.00/02 and /03. The route of the water furrow is historical and it should not be modified.

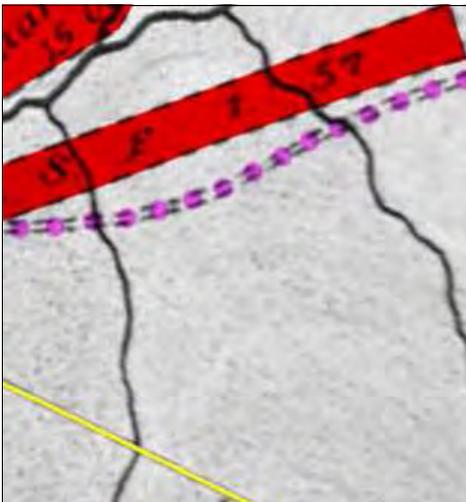
Photo Title
1902 map: Red blocks 17th century grants, yellow lines early 19th c, pink dots roads. Grey/black rivers.

This water meadow was part of the land along the river granted to the Free Black Jan of Ceylon in 1692 (Photo 6). Soon after, he and his successors started using any convenient arable land adjacent. The remainder of this property was only officially granted in 1817 (see Old Nectar Historical Property). Early farmers dug ditches to drain the water-logged soil adjacent to the Eerste Rivier. To irrigate the rising land, they took a water channel behind it, as close as they could to the suddenly steeper slope (See 02.00/03). This still exists though its construction has changed radically over the years. It is taken off the Eerste Rivier at Swiss Camp (02.13) and crosses Pontrieux and the corner of Waterfalls before it enters this property in the north-east. It flows behind the house cluster and continues along the south side of the meadow where it feeds a dam. It then continues to Glen Connor. The old road from Stellenbosch to Jonkershoek farm and Assegaibosch ran somewhere close to this line. The nearby bridge across the Eerste was made in the early 20th century when a new road was made on a different alignment.

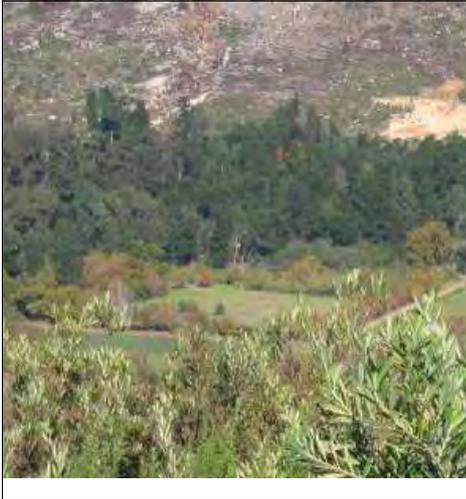
Waterhof, view from Konstanz. The water meadow is left of the road to Waaiwinde at centre, with treed slopes behind. The house is left of it.

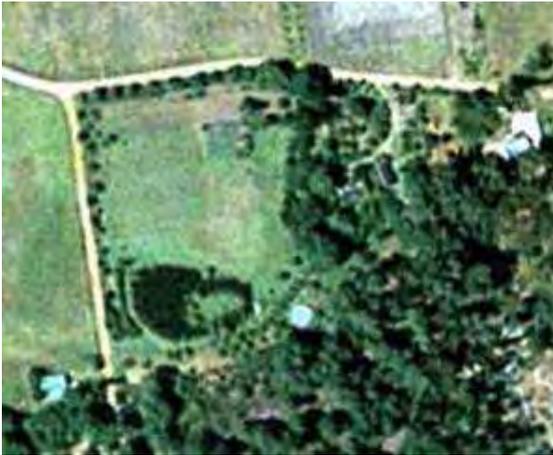
Waterhof homestead, 2000 aerial photo.

The homestead is in the north east corner of the property, on part of the water meadow. It has a small citrus orchard in front with a circular drive, and is surrounded by shrubberies, including bamboo groves. There is a swimming pool behind and west of the house. See Objects.

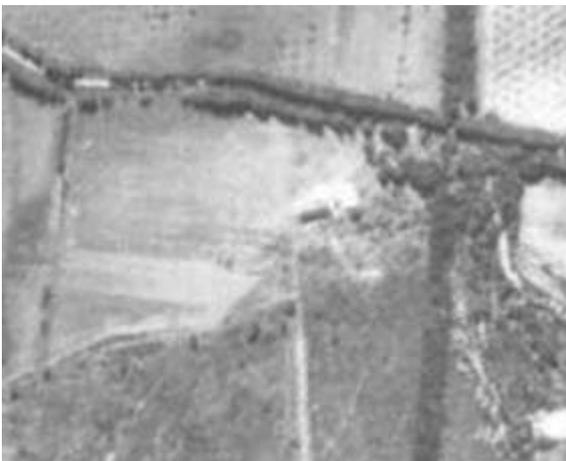
Waterhof homestead, 1938 aerial photo.

See Property. The dwellings are visible on the 1938 aerial photo.

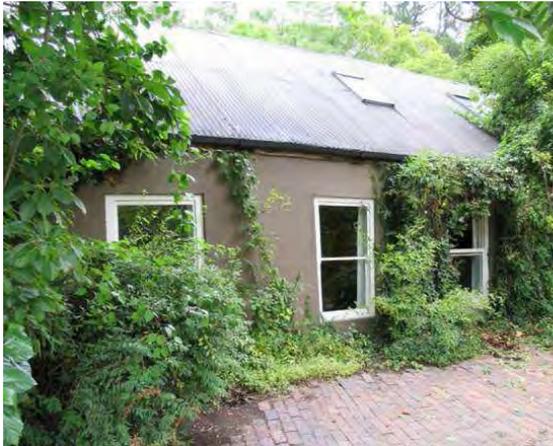
Main house, Waterhof

Two simple single storey cottages with corrugated iron roofs, set in dense shrubbery. The main house faces the road; it has roof windows parallel to the surface and modern sash windows. A cottage is at right angles to the house, facing east and connected to it by a carport roof. It has an external chimney and a loft window at one end, two doors and casement windows.

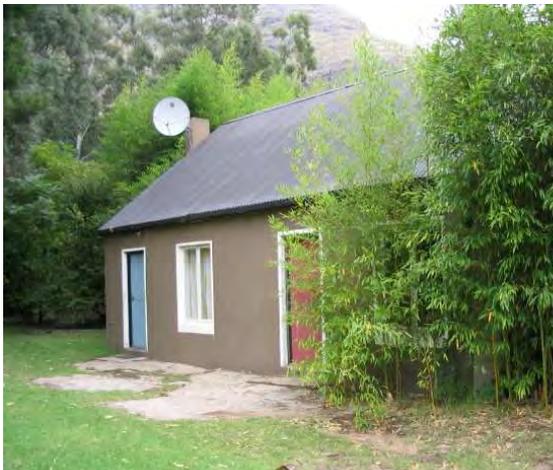
Cottage, Waterhof

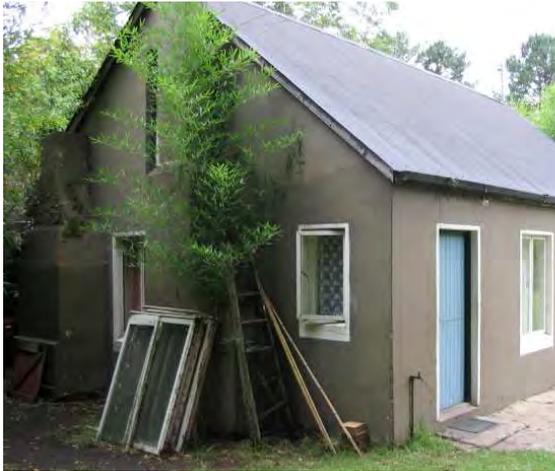
Cottage, Waterhof. Note protruding chimney on end gable.
