SITE NAME: VREDENHEIM (VREDENBURG, VLOTTENBURG,

LANDSCAPE UNIT NUMBER: C07
LANDSCAPE UNIT GRADE: Grade II

PROPERTY NO
 SITE ADDRESS Vlotenburg Road and R310
 CURRENT USE Agricultural Werf
 ORIGINAL USE Agricultural werf

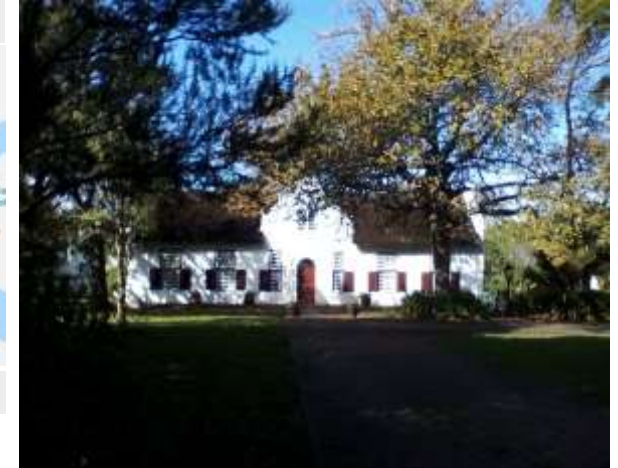
Fine Cape Dutch homestead and werf with unique front gable. H-shaped house with small addition to the east, and fine, established garden with surrounding werf wall. The "modern," shed buildings to the east accommodate the restaurant and wine tasting facilities, while sheds set back to the west of the house comprise the working elements of the farm.
