SITE NAME: ASSEGAAIBOS HOMESTEAD

LANDSCAPE UNIT NUMBER: D02
LANDSCAPE UNIT GRADE: Grade II

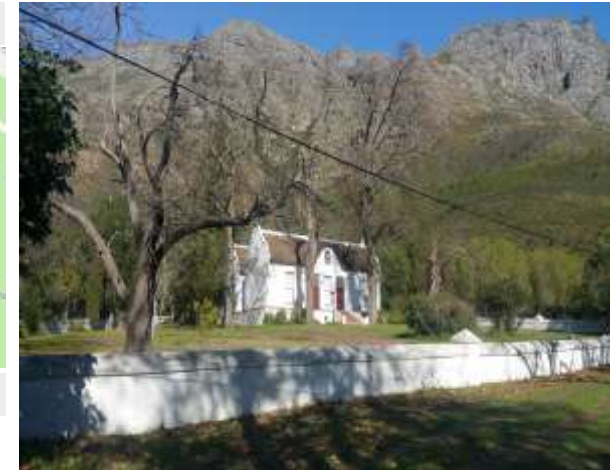
Late 18th / early 19th century H-shaped dormer gabled house with thatch and surrounding raised stoep. Unusual facade with two doors symmetrically flanking central window. It was restored to its current appearance in 1965 (see Fransen, 2004: 199). Centerpiece to the historic werf with low white werf-wall around (werf now smothered by newer additions). Current style after restoration by Cape Nature: H-shaped Georgianised facade, a central dormer gable of rolled thatch with a 3x4 casement window. A central large-pane 4x6 sash window, flanked by panelled double doors with rectangular fanlights.
