SITE NAME: BRAKELSDAL (ANNANDALE)

LANDSCAPE UNIT NUMBER: C16
 LANDSCAPE UNIT GRADE: Grade II

PROPERTY NO
 SITE ADDRESS Corner Annandale Road and R44
 CURRENT USE Agri-Industrial
 ORIGINAL USE Agricultural werf

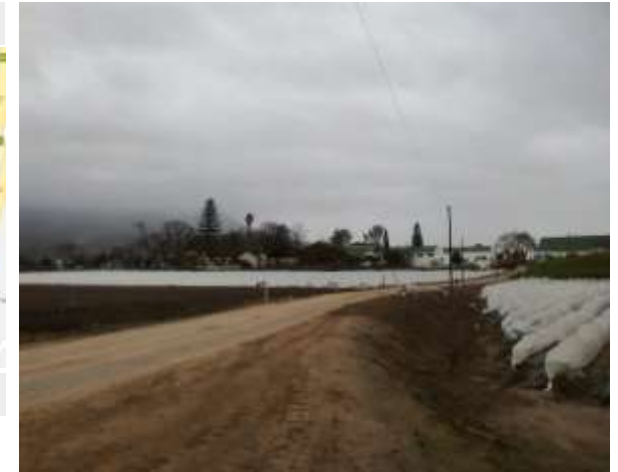
The homestead would once have been U-shaped under a thatched roof, but now is under hipped corrugated-iron roof, with extensions and replaced elements. A modest homestead, now embedded within an industrial complex and barely discernable from the agri-industrial structures.
