**SITE NAME: 3 CLUVER ROAD**

PROPERTY NO 16238  
SITE ADDRESS 3 Cluver Road  
CURRENT USE Residential  
ORIGINAL USE Student Housing Complex

Curr.NHRA Protection S34  
>60YRS? **Yes**  
PROPOSED GRADING Grade IIIc

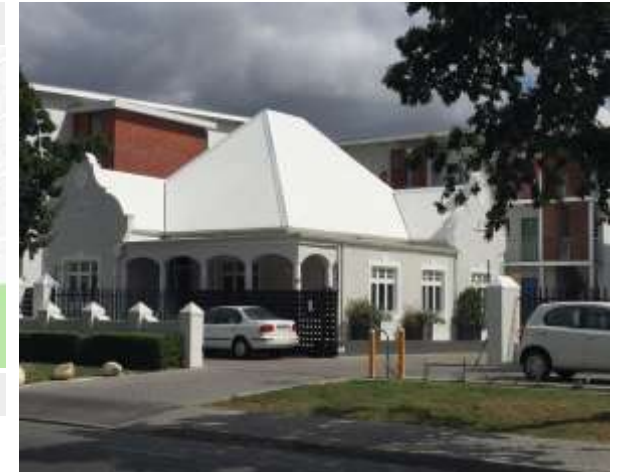
Cape Revival villa, with two end bays and a corner stoep with arched openings on Doric columns. Original/restored timberwork, vents set into the gables, and plaster elaboration on the gables. The main, hipped roof volume has been lifted and appears to be out of proportion.

The roof pitch has been changed and appears out of proportion with the rest of the building.
