SITE NAME: 5 CLUVER ROAD

PROPERTY NO 16394
SITE ADDRESS 5 Cluver Road
CURRENT USE Residential
ORIGINAL USE Student Housing Complex

Curr.NHRA Protection S34
>60YRS? **Yes**
PROPOSED GRADING Grade IIIc

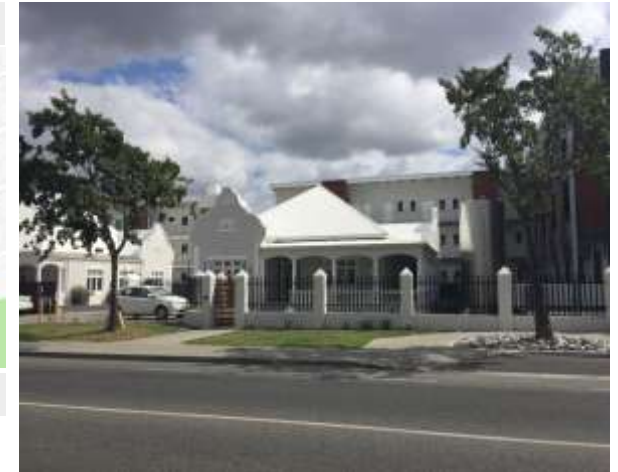
Cape Revival villa, with two end bays and a corner stoep with arched openings on Doric columns. Original/restored timberwork, vents set into the gables, and plaster elaboration on the gables.

Unfortunately the houses (No. 3 and 5) have lost their front gardens entirely to parking areas. Mature oaks on the pavement contribute to the streetscape.
