SITE NAME: 6 CLUVER ROAD

PROPERTY NO 16361
SITE ADDRESS 6 Cluver Road
CURRENT USE Residential
ORIGINAL USE Residential

Curr.NHRA Protection S34
>60YRS? **Yes**
PROPOSED GRADING Grade IIIc

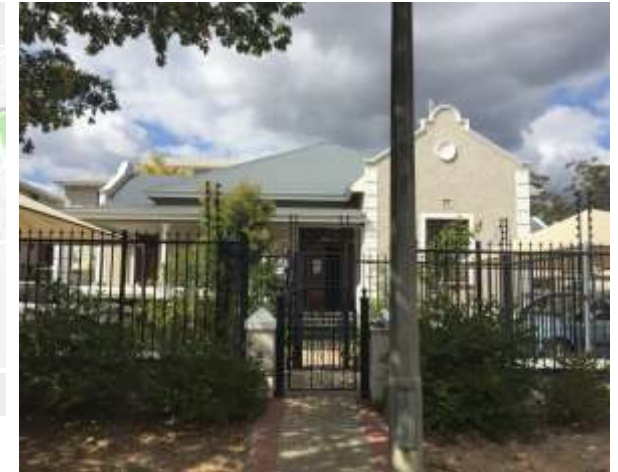
Cape Revival villa, with two end bays and a corner stoep with arched openings on Doric columns. Original/restored timberwork, vents set into the gables, and plaster elaboration on the gables and walls.

The car sunshades and other office park paraphernalia around the house detracts.
