SITE NAME: 96 MERRIMAN STREET

PROPERTY NO 2321
SITE ADDRESS 96 Merriman Street
CURRENT USE Residential
ORIGINAL USE Student Housing

Curr.NHRA Protection S34
>60YRS? **Yes**
PROPOSED GRADING Grade IIIc

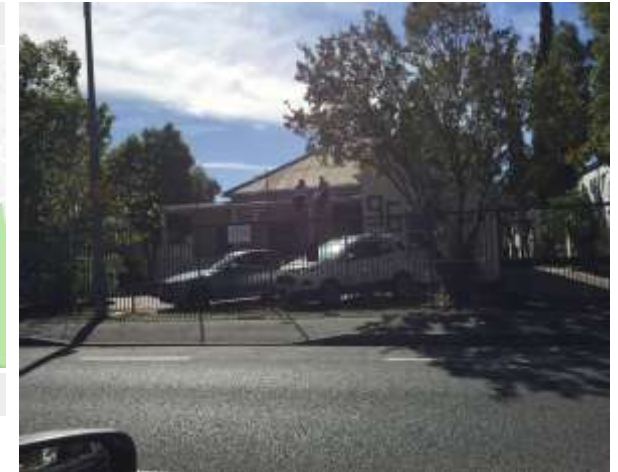
Cape Revival villa, with Cape Revival gable on end bay, and a corner stoep supported on Doric columns. Original/restored timberwork for front door, but replaced windows. Circular vent set into the gable, and plaster elaboration on the gable adds to the structure.

Security apparatus and fittings detract.
