SITE NAME: 98 MERRIMAN STREET

PROPERTY NO 2320
SITE ADDRESS 98 Merriman Street
CURRENT USE Residential
ORIGINAL USE Student Housing

Curr.NHRA Protection S34
>60YRS? **Yes**
PROPOSED GRADING Grade IIIb

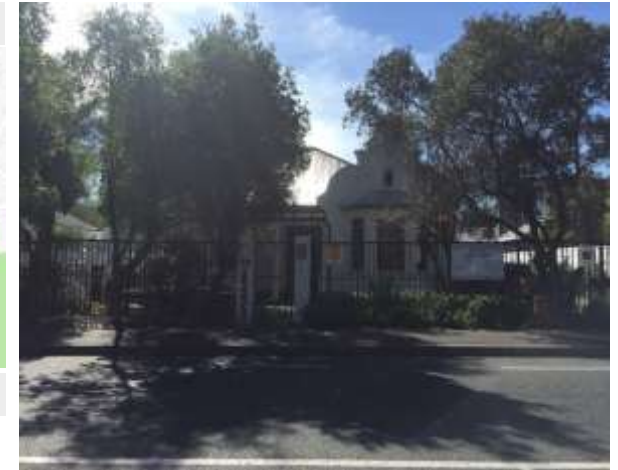
Cape Revival villa, with highly decorative Cape Revival gable on end bay, and a corner stoep supported on Doric columns. Original/restored timberwork for front door and windows. Circular vent set into the gable, and plaster elaboration on the gable adds to the structure.
