SITE NAME: KLAPMUTS HOTEL COMPLEX.

LANDSCAPE UNIT NUMBER: I01
LANDSCAPE UNIT GRADE: Grade II

PROPERTY NO 104
 SITE ADDRESS Klapmuts historic core
 CURRENT USE Hotel, restaurant, bar and small casino
 ORIGINAL USE Hotel

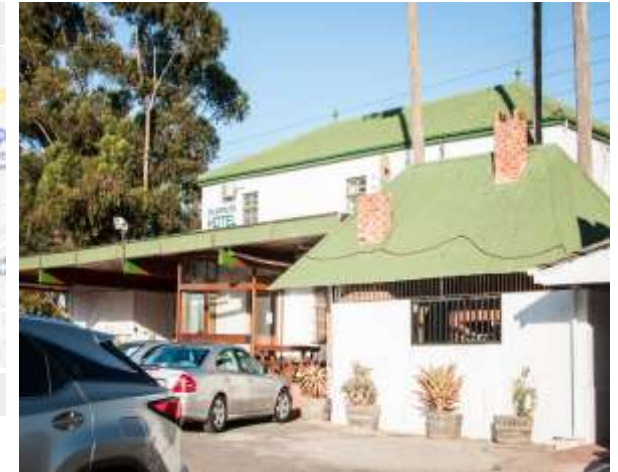
Hotel complex. Double-storey two-rooms deep, hipped-roof five-bay building with stoeps upstairs and downstairs; retains Victorian sash windows upstairs. Attached single-storey pitched-roof extension. Adjacent Art Deco building. Tall palms and remnants of Eucalyptus avenue.

Location and role with regards to road and rail infrastructure is important. Intact Victorian structure (rare). Together with the station and church and bluegum trees, this 'precinct' had significance but is badly compromised and neglected.

Pizza Shed, casino structure and roof additions.
