**SITE NAME: REYNEKE WERF (UITZICHT)**

**LANDSCAPE UNIT NUMBER: C01**  
**LANDSCAPE UNIT GRADE: Grade II**

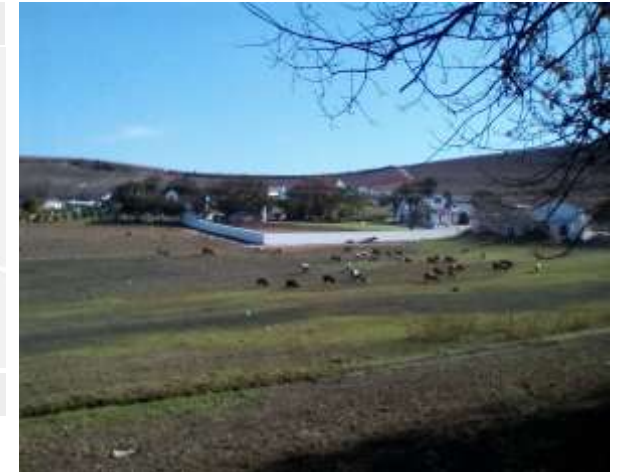
A werf complex with farmhouse and wine cellar. The house may have an original core, but is much altered. A bell-tower is evident in the garden alongside the house. A modern wine cellar, in fairly sympathetic style, is located to the north. There is a modern "werf wall" that may follow an historic alignment. Trees of maturity edge the space.

Very tall "werf wall" - possibly built on the alignment of an older werf wall. The farmhouse could be a pastiche - it has been modernised, with very vertical proportions, but may have an historic core.
