**SITE NAME: DIGTEBY ESTATE**

**LANDSCAPE UNIT NUMBER: C06**  
**LANDSCAPE UNIT GRADE: Grade II**

PROPERTY NO 40  
 SITE ADDRESS Road between Vloottenburg Railway Station and Vloottenburg  
 CURRENT USE Gated housing development  
 ORIGINAL USE Agricultural

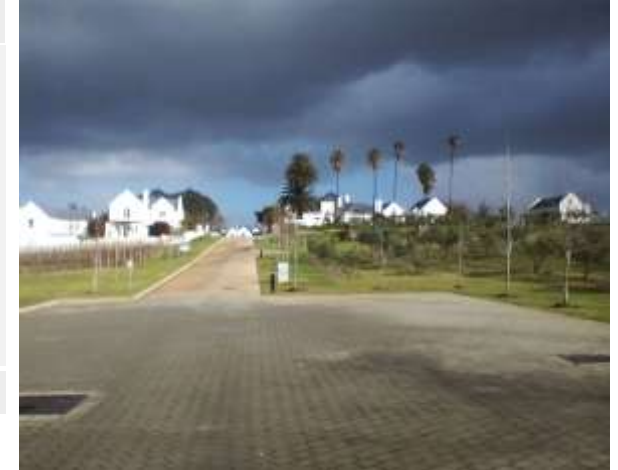
This house is located within a gated housing development, but may be of some age. The mature Palm trees surrounding the structure attest to a structure of at least 90 years of age. However, the house itself appears to have been over-sanitised as part of the development of the housing estate.

Mature oaks and palm trees surround the house

Has lost its original werf/yard space. However, it occupies a prominent position on the hillside and so has some landmark significance.

Yes - over-sanitisation as part of the housing estate development.
