SITE NAME: VLOTTENBURG NODE BUILDING (1931)

LANDSCAPE UNIT NUMBER: C06
 LANDSCAPE UNIT GRADE: Grade II

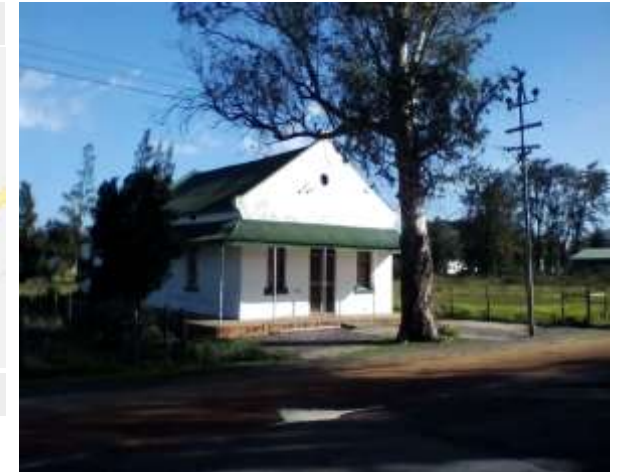
Simple long house plan, pitched roof with end gables, original windows and six-panel teak French door with curved fanlight, simple metal posts supporting veranda on two sides. Dated 1913. Round ventilator in gable. Likely religious.

Addition to the back, and to the stoep
