Heritage Survey: Stellenbosch Rural Areas

by Penny Pistorius and Stewart Harris - June 2004

02.03

Mount Happy, Jonkershoek, Stellenbosch District

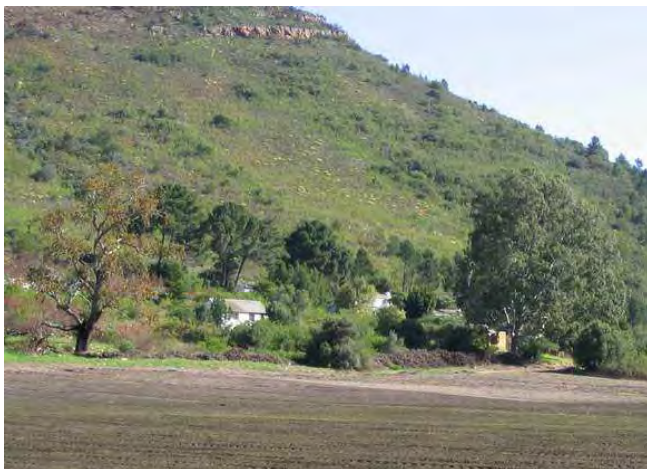
Cottages from the field. The ruin is under the large gum tree, R.

East of the werf is a cluster of workers' housing on the lower slopes, watered by a stream. Most of the houses are apparently modern (not inspected in detail), but there is one old, roofless, ruined cottage near the edge of the field (See Objects). There is another cluster of workers' housing north of the river -- see Composite 02.03/03, Object 3.

There were two or three houses here by 1938, of which only one apparently still exists as a ruin (see Objects).

The village, including associated vegetation, paths, etc. should not be removed or fundamentally changed without further research into the history of the dwelling site. See also Objects.

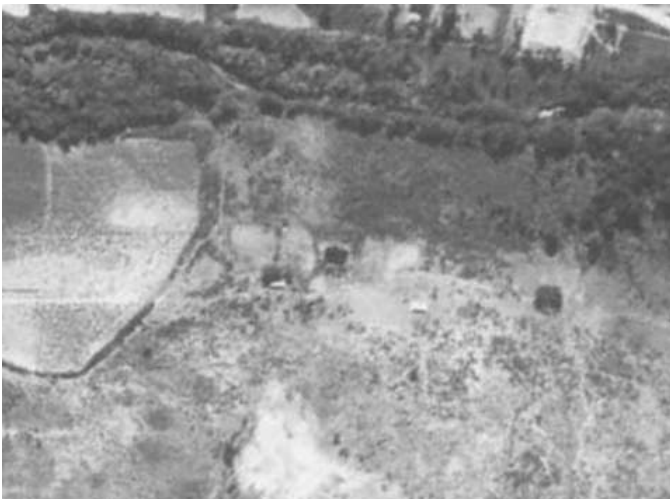
1938 aerial photo shows two, possibly three, cottages

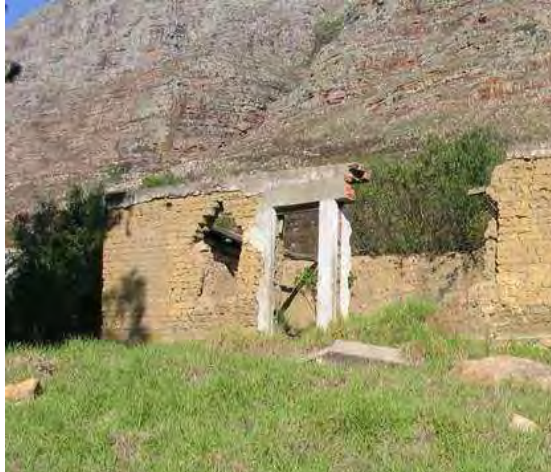
Ruined cottage, Mount Happy

The ruin of a small two-roomed cottage built with stone foundation and unfired mud brick walls with mud mortar, and a later wall at one end. It had a parapet and flat corrugated iron roof on poplar beams. This may have been a later modification as the parapet wall is built of fired bricks, as is one end wall. There is no surviving joinery.

Ruin

The cottage may be older than 60 years; it is difficult to make out on the 1938 aerial photo.

Natural decay.

Should be allowed to continue to decay naturally.

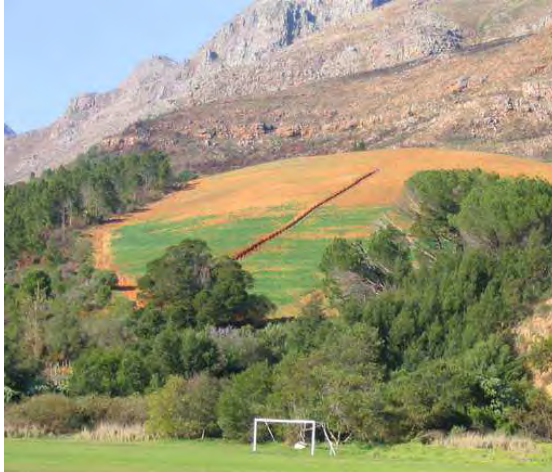
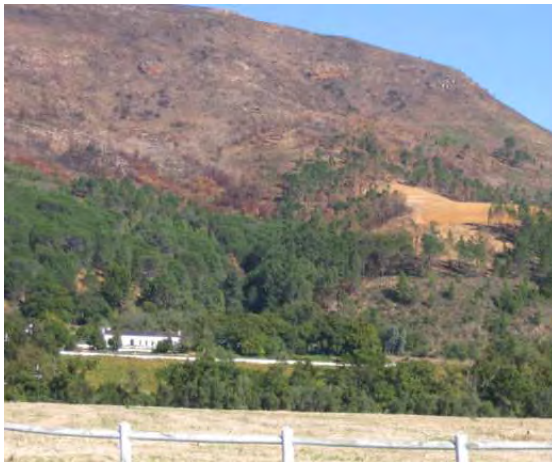
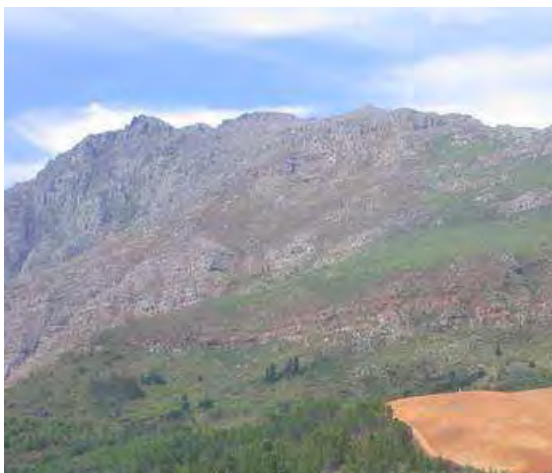
High Field from Vergenoegd sportsfields

High Field from Jonkershoek Road, showing relationship to werf

High field from Lanzerac.

The top and west side of the hill to the west of the werf is a large field, cultivated but not planted at the time of survey. It is a highly visible landmark at the entrance of the valley.

The field is not visible as cultivated land on the 1938 aerial photograph, and must have been established subsequently.

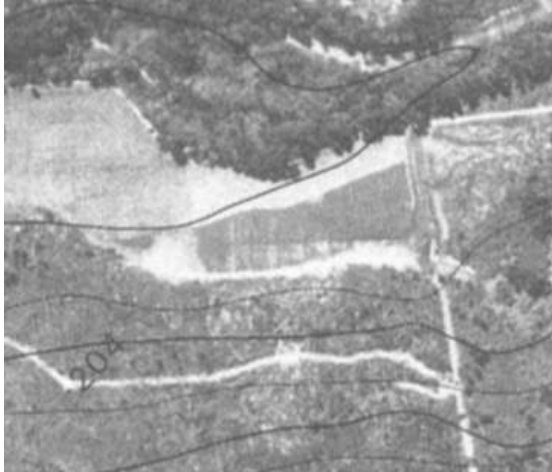
Orthophoto showing earthworks

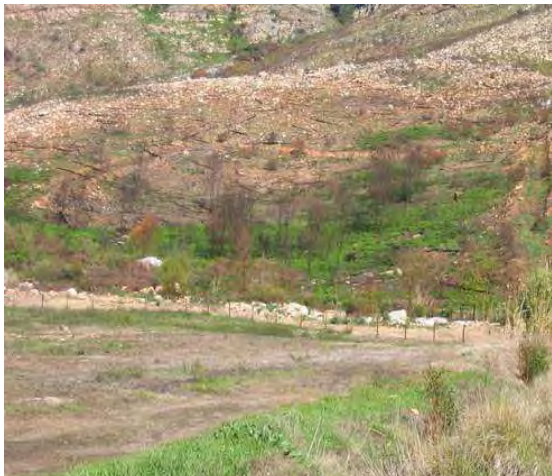
Earthworks on slopes near east boundary from newly cleared field below

On the lower slopes near the east boundary is a prominent ditch which cuts across the contour with two downward "arms: from each end. Presumably its purpose is to channel and direct water.

Not visible on the 1938 aerial photo, it must have been constructed subsequently.

This landscape modification appears as a scar on the sparsely-vegetated lower slopes. Its purpose is unknown, but it appears to be a water channelling device.

Further research necessary.

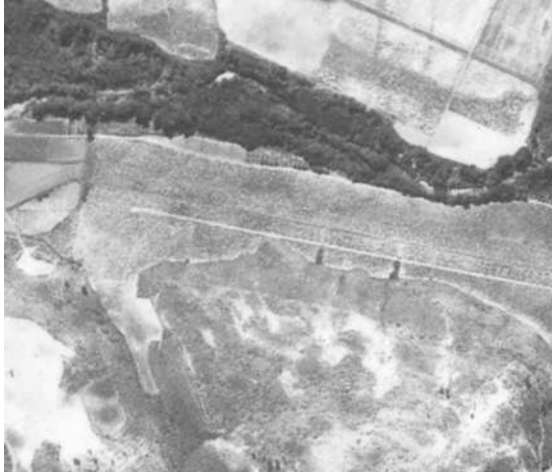
1938 aerial photo with old approach through vineyards clearly visible. Werf is centre right, with avenue. The road entered the werf at the north west corner and crossed it inside the wall.

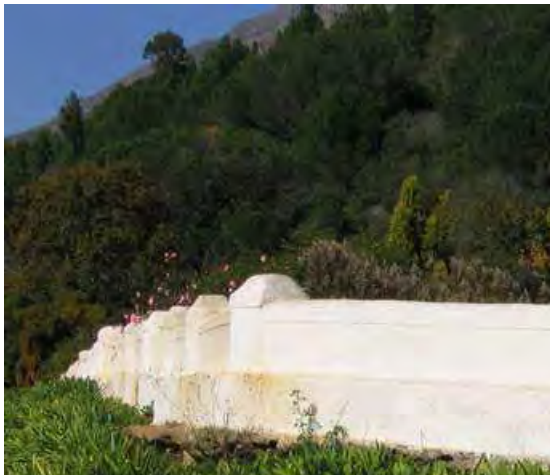
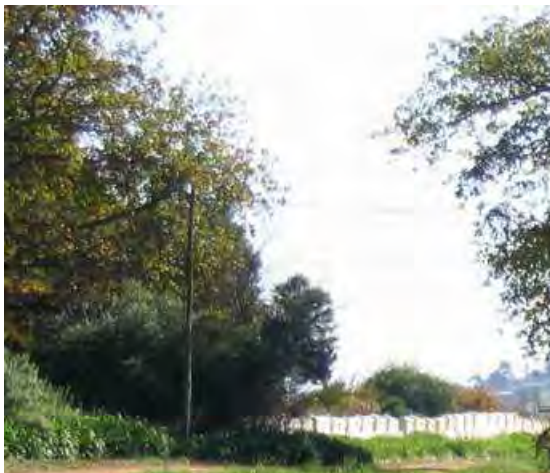
Mount Happy werf wall

The werf is backed by Stellenboschberg in the south and the remaining three sides are enclosed in a plastered wall with a foundation of rounded river stones. It has pillars at regular intervals with rounded square caps and the wall itself has a rounded capping. There are two gateways in the north wall: one in the east and one in the west opposite the side of the house. The side walls step down the slope; the front wall is on a bank above the road that runs in front of it.

Unknown, but the enclosure of the farmstead by walls is a defining feature of Cape werfs over a long period. Probably made soon after 1817 when the werf was established. Much repaired over the years.

Retain and repair as required; should not be over-restored.
