Heritage Survey: Stellenbosch Rural Areas

by Penny Pistorius and Stewart Harris - June 2004

Assegaaibosch, Jonkershoek, Stellenbosch District

Assegaaibosch

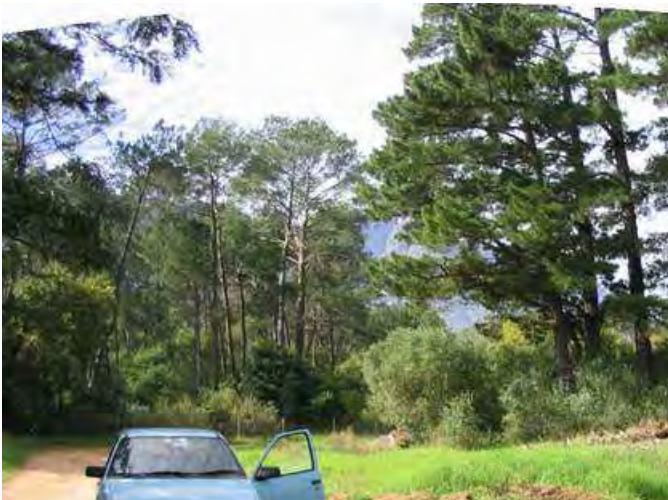
Pine trees between houses 1 and 2 and the prefab housing area (3).

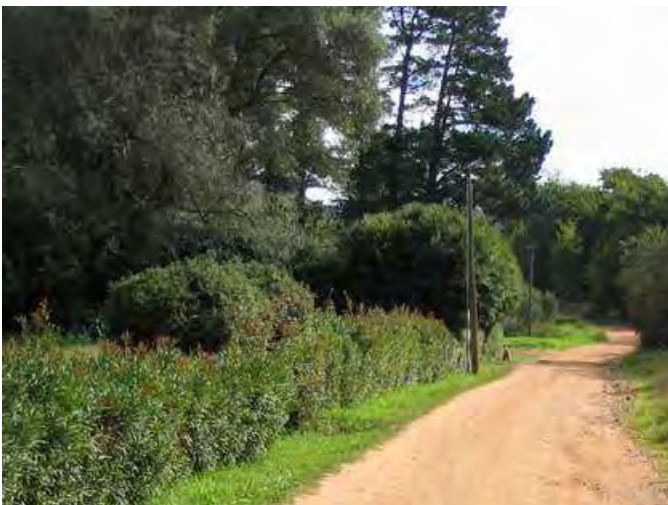
The road in front of houses 1 and 2, looking west towards the pine trees.

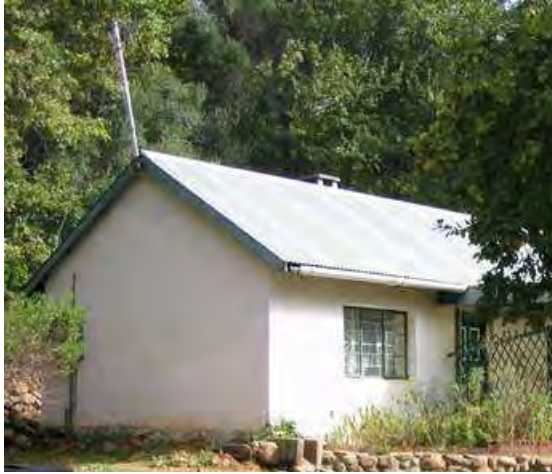
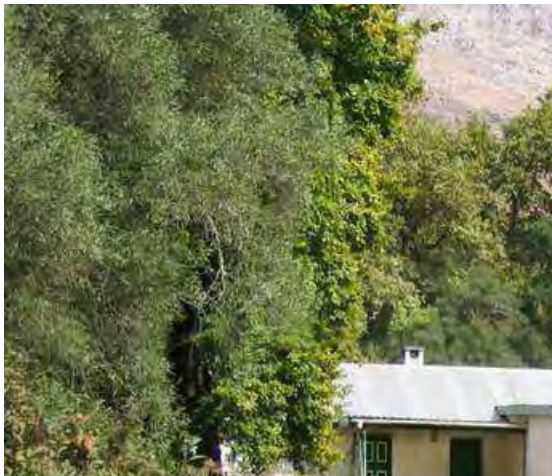
Staff house west 1

Simple cottage with corrugated iron roof, masonry walls. Stoep in front, , natural stone plinth, part-roofed. Projecting extension on left with monopitch roof. Steel windows; early 20th C (?) panelled door. In a neat garden with stone path, surrounded by trees and hedges.

Appears on 1938 aerial.

This vernacular cottage is altered but retains its proportions. With its garden setting it contributes to the cultural landscape.

Should be retained; could be appropriately renovated.

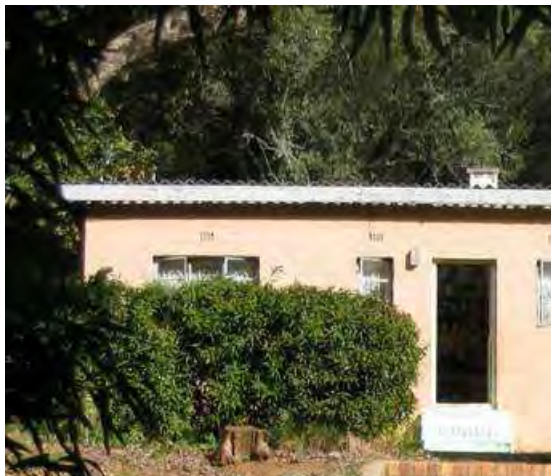
Staff house west 2

Undistinguished cottage with steel windows, low-pitched roof. Set in a garden with Port Jackson hedges, surrounded by trees.

No intrinsic heritage values, but the dwelling site is well-chosen and charming; contributes to landscape.

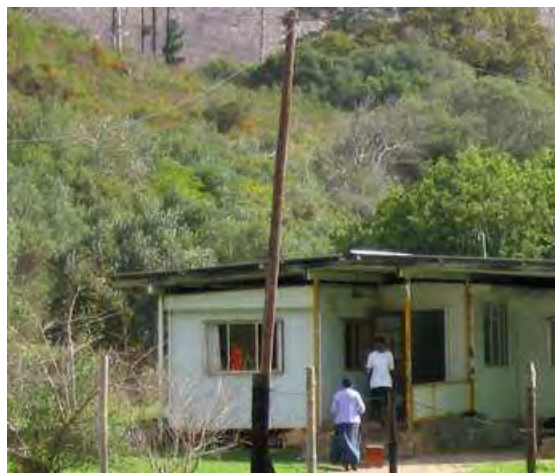
Typical prefabricated house in the Assegaibosch west group.

A cluster of prefabricated dwellings (made of mobile homes?) occupies the north west corner of Assegaaibosch. The surroundings are neat and the "camp" is well-established despite the temporary appearance of the prefabs.

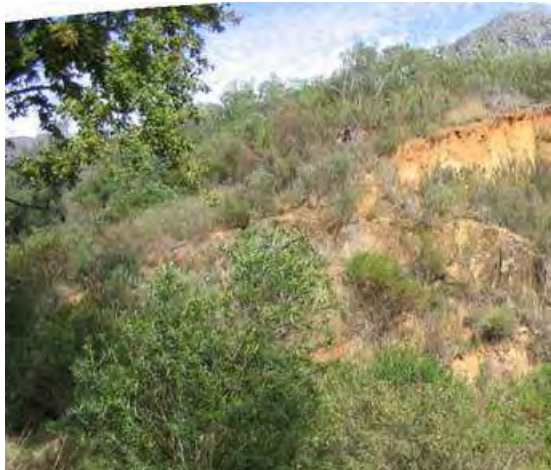
Old Quarry, Assegaaibosch.

Where the hill pushes forward towards the road, it has been cut away by quarrying activities, presumably for road-making and maintenance., leaving an exposed clay bank. An old concrete roller stands alongside the road.

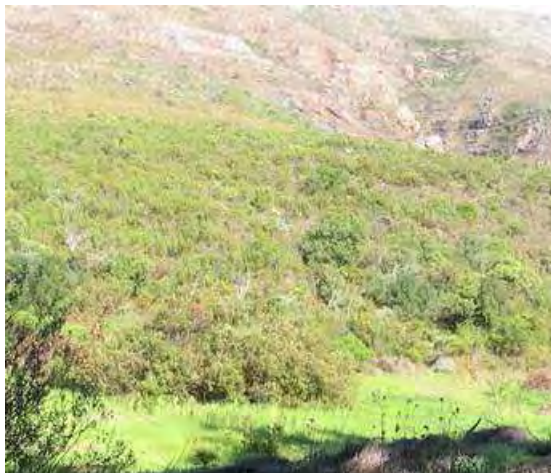
Triangle Field, Assegaaibosch

Triangular shaped water meadow next to the old road, enclosed by the folds of the west hill. Presently lying fallow and overgrown with kikuyu; evidently used for dumping at some stage.
