COETZENBURG ANNEXE (MARKOTTER/CRAVEN RUGBY MUSEUM)

PHYSICAL ADDRESS:	Coetzenburg	ERF:	Farm 306, Part 1
ARCHITECTURAL PERIOD:	Cape Dutch	DATE BUILT:	mid-18th C
STYLE:	Cape Vernacular	TYPE OF BUILDING:	Agricultural
ZONING:		USE:	Mixed Use

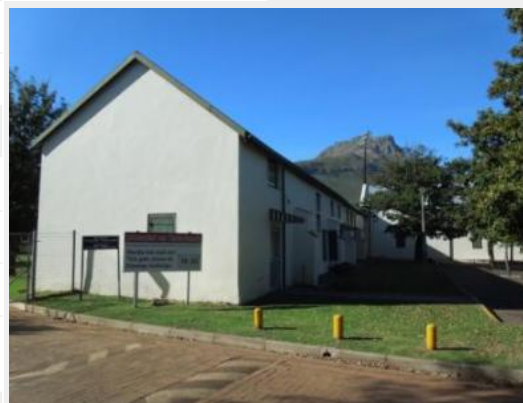
DATE OF PHOTOGRAPH(S): 6 MAY 2013

SITE & STRUCTURE DESCRIPTION:	"Long building at right angles to the homestead and barn, buttressed. Corrugated iron roof with barge board matching house and clipped end gables. Various woodwork: 8-pane windows to loft, sashes with solid shutters and casements with shutters, simple stable doors."
HISTORY:	
SOCIAL HISTORY:	
ALTERATIONS:	
GENERAL EVALUATION:	Significant
SUGGESTED GRADING:	IIIA
DATE OF SURVEY:	November 2009
