KNORHOEK (KLEYGAT)

PHYSICAL ADDRESS:	R44 Knorhoek Road	ERF:	
ARCHITECTURAL PERIOD:		DATE BUILT:	
STYLE:		TYPE OF BUILDING:	
ZONING:		USE:

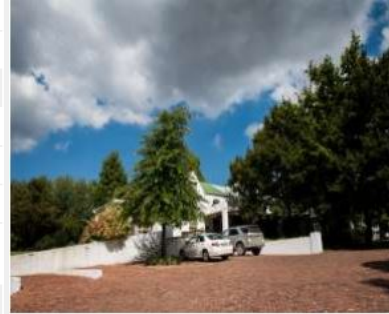
SITE & STRUCTURE DESCRIPTION:	Originally Cape Dutch, after late 19th century fire the roof was replaced with an enormous overall pitched roof with ridge running from front to back gables. Gable (1827) outlines still visible. Several other alterations. Mature oaks.
HISTORY:	
SOCIAL HISTORY:	
ALTERATIONS:	
GENERAL EVALUATION:	
SUGGESTED GRADING:	IIIB
DATE OF SURVEY:	2016
