98 MERRIMAN STREET

PHYSICAL ADDRESS:	98 Merriman Street	ERF:	2320
ARCHITECTURAL PERIOD:		DATE BUILT:	
STYLE:		TYPE OF BUILDING:	
ZONING:		USE:

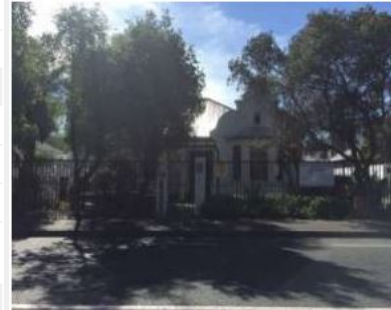
SITE & STRUCTURE DESCRIPTION:	Cape Revival villa, with highly decorative Cape Revival gable on end bay, and a corner stoep supported on Doric columns. Original/restored timberwork for front door and windows. Circular vent set into the gable, and plaster elaboration on the gable adds to the structure.
HISTORY:	The house appears on the c1938 aerial photography for the area.
SOCIAL HISTORY:	
ALTERATIONS:	
GENERAL EVALUATION:	
SUGGESTED GRADING:	IIIB
DATE OF SURVEY:	2016
