**SITE NAME: 60 MERRIMAN ROAD, STELLENBOSCH**

PROPERTY NO 13847  
SITE ADDRESS 60 Merriman Road  
CURRENT USE University office  
ORIGINAL USE Residential

Curr.NHRA Protection S34  
>60YRS? **Yes**  
PROPOSED GRADING Grade IIIa

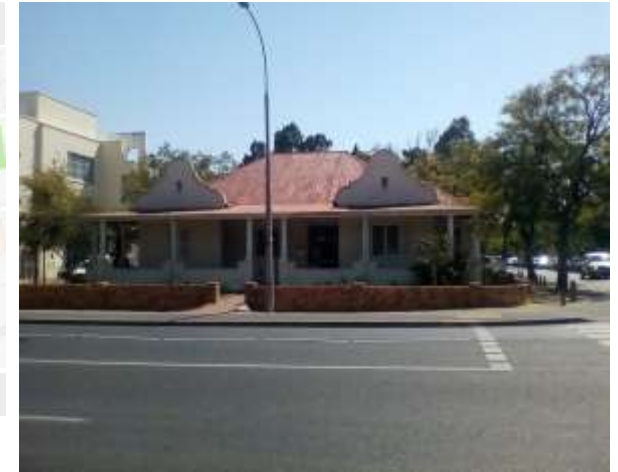
Single-storey, quasi-symmetrical, with two Cape Dutch Revival gables, evidence of original joinery, quoining, some 1920s doors, etc.
