SITE NAME: 70 MERRIMAN ROAD, STELLENBOSCH

PROPERTY NO 2409
SITE ADDRESS 70 Merriman Road
CURRENT USE Residential
ORIGINAL USE Residential

Curr.NHRA Protection S34
>60YRS? **Yes**
PROPOSED GRADING Grade IIIa

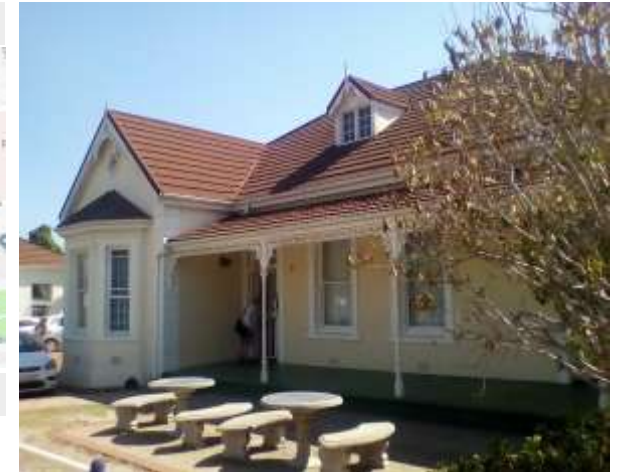
Single-storey asymmetrical villa, with replacement Marley tile roof but with original gable fretwork and dormer. Original doors and windows, original "broekie lace" stoep columns and brackets, stoepkamer, some original shutters. Stoep used to wrap round.
