SITE NAME: CORRUGATED IRON COTTAGE

PROPERTY NO RE/452
SITE ADDRESS Parfaite Street
CURRENT USE House
ORIGINAL USE House

Curr.NHRA Protection S34
>60YRS? **Yes**
PROPOSED GRADING Grade IIIc

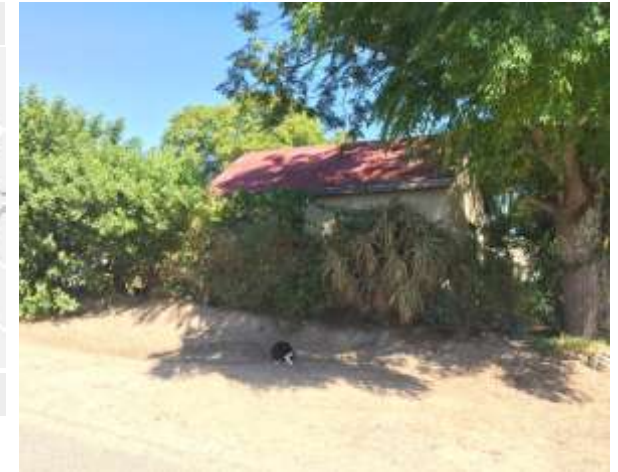
This is a single-storey cottage, under double-pitched iron roof with end gables and lean-to to the back. The structure is an interesting example because it is constructed of corrugated-iron clad timber frame.
