SITE NAME: 37 BOSMAN STREET

PROPERTY NO 2403
SITE ADDRESS 37 Bosman Street
CURRENT USE Residential
ORIGINAL USE Residential

Curr.NHRA Protection S34
>60YRS? **Yes**
PROPOSED GRADING Grade IIIc

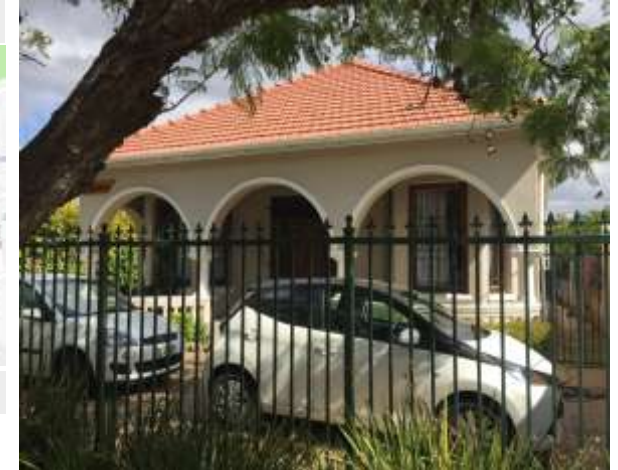
Early 20th Century cottage under hipped, corrugated iron roof with arched veranda across the full width of the street facade. Visually-transparent fencing to street edge. Bay window to side, and seemingly-original front door and sash windows.

The arched veranda may be a later addition, with the core building being Victorian.

Insensitive alterations and additions.
