SITE NAME: HOTEL SCHOOL VLOTTENBURG

LANDSCAPE UNIT NUMBER: C06
 LANDSCAPE UNIT GRADE: Grade II

PROPERTY NO
 SITE ADDRESS Road between Vloottenburg Railway Station
 CURRENT USE Hotel school
 ORIGINAL USE Residential

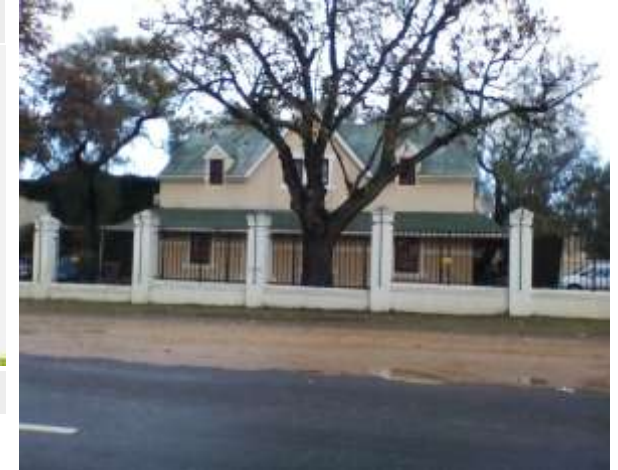
House with werv fragments. Bottom storey has original elements. 6 pane sash windows, interior shutters, plaster surrounds, four panel typical Victorian doors with arched upper panel, simple fanlight, plaster banding along stoep, re-done catslide stoep roof, posts possibly original.

Boundary fence with electric wiring, some outbuildings to the south-east.
